丸亀城石垣の勾配

帶曲輪石垣（H面、I面）崩落前平面図

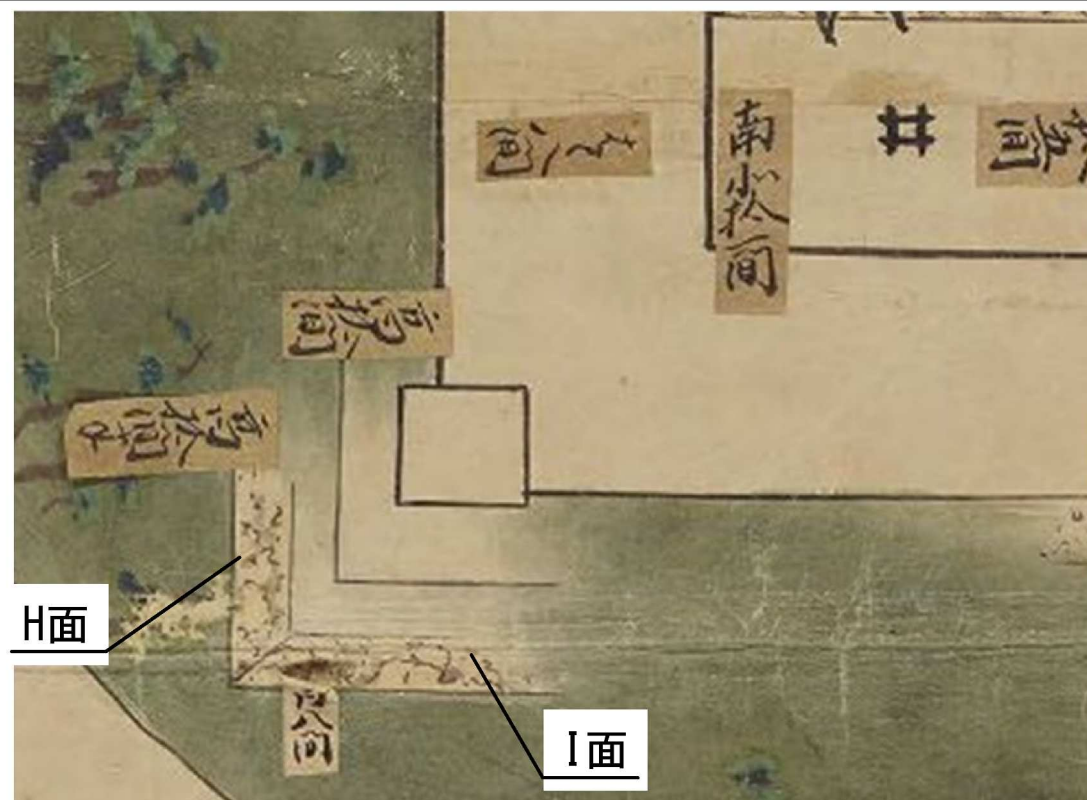
正保城絵図（1645 年）

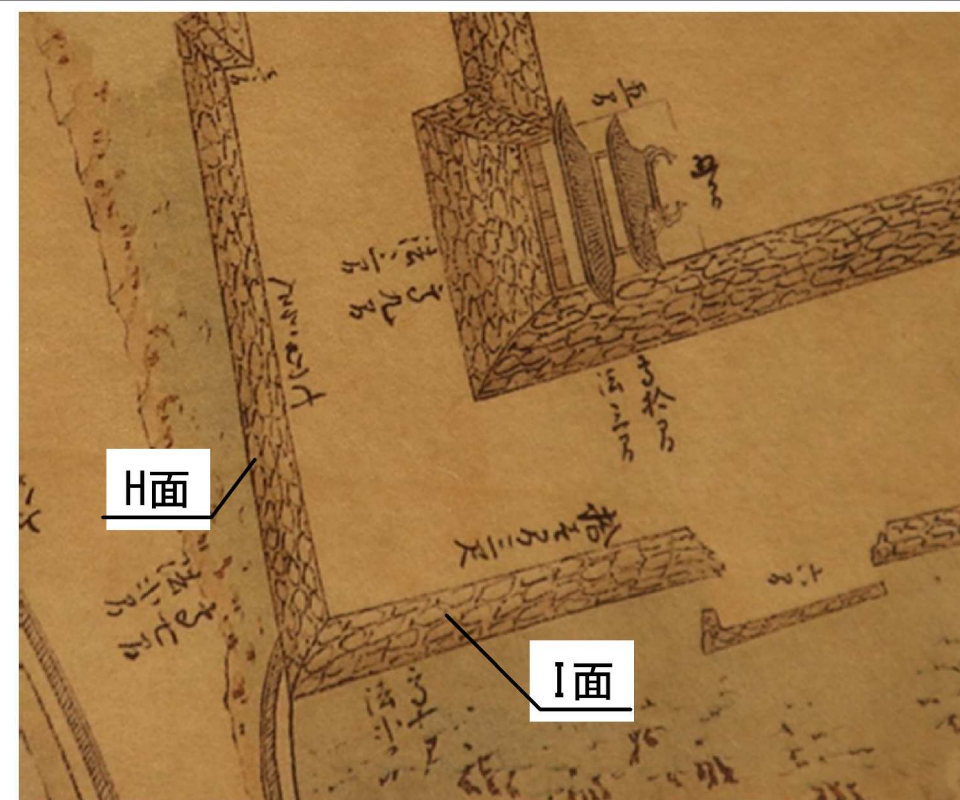
山崎時代の丸亀城郭絵図（1657～1658）

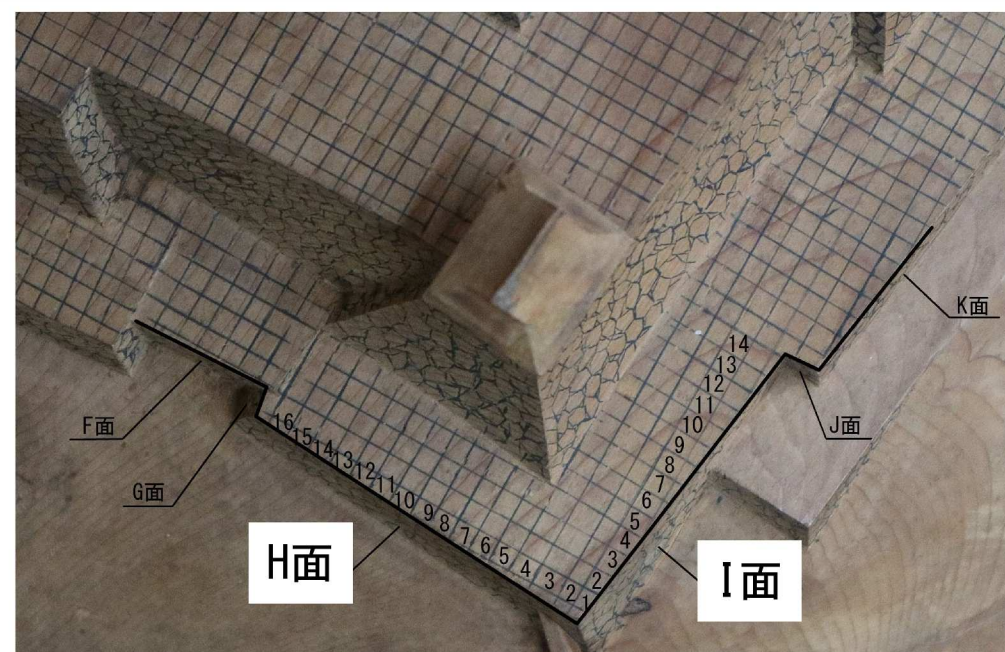
丸亀城木図（1670 年頃）

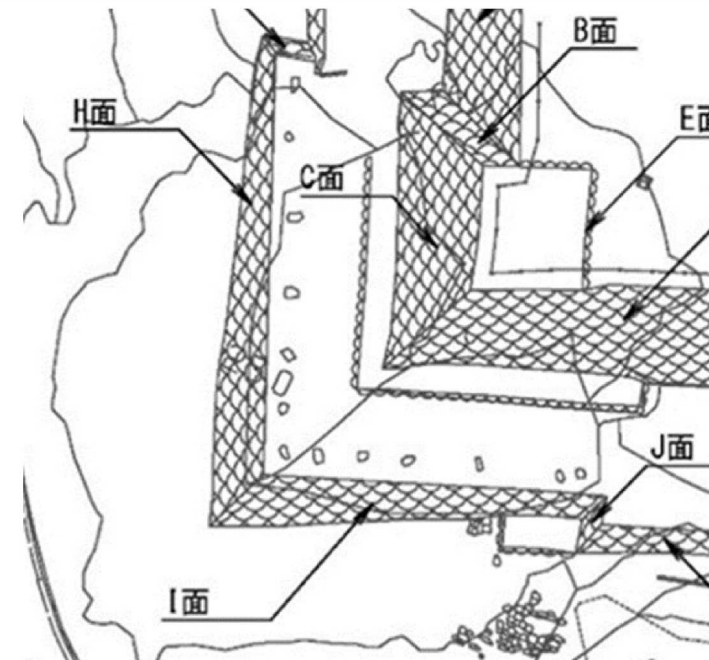
現況帯曲輪石垣（H 面 I 面位置）

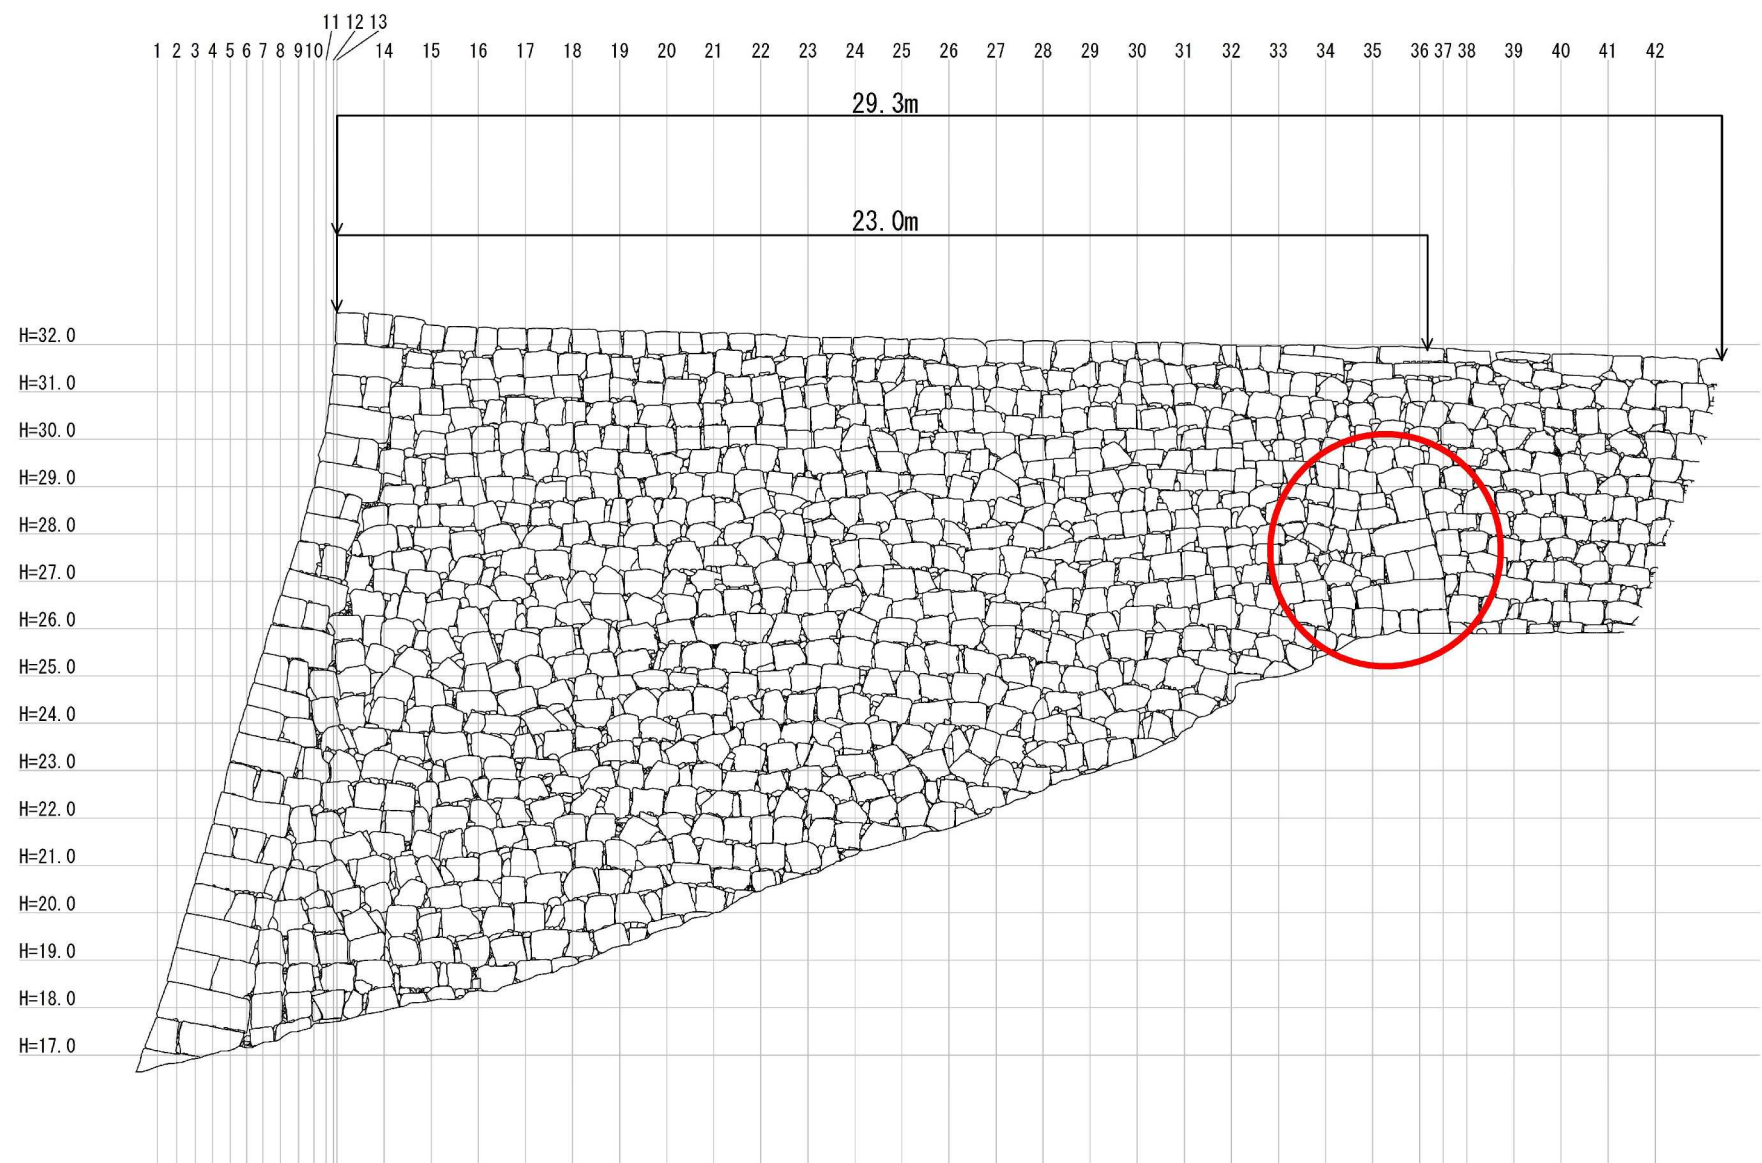
I 面立面図における算木積みの位置

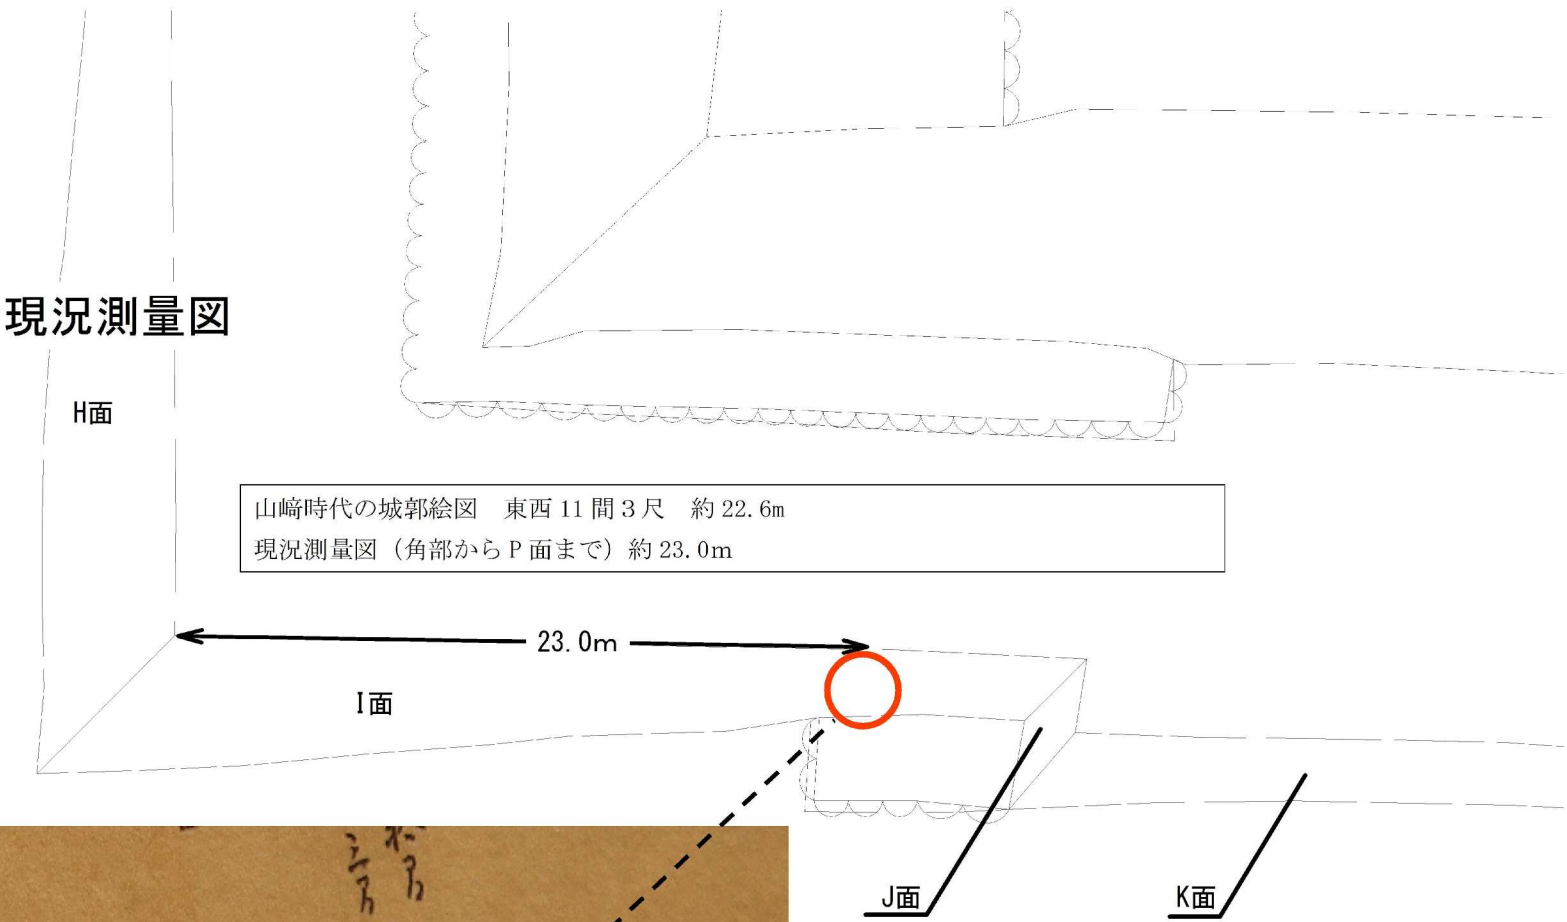
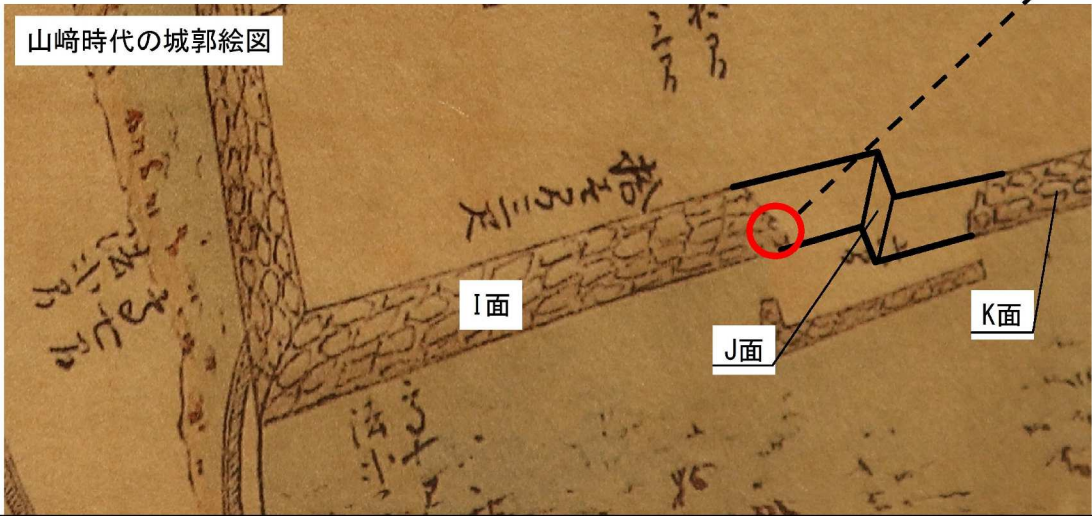
現況測量図と城絵図の比較

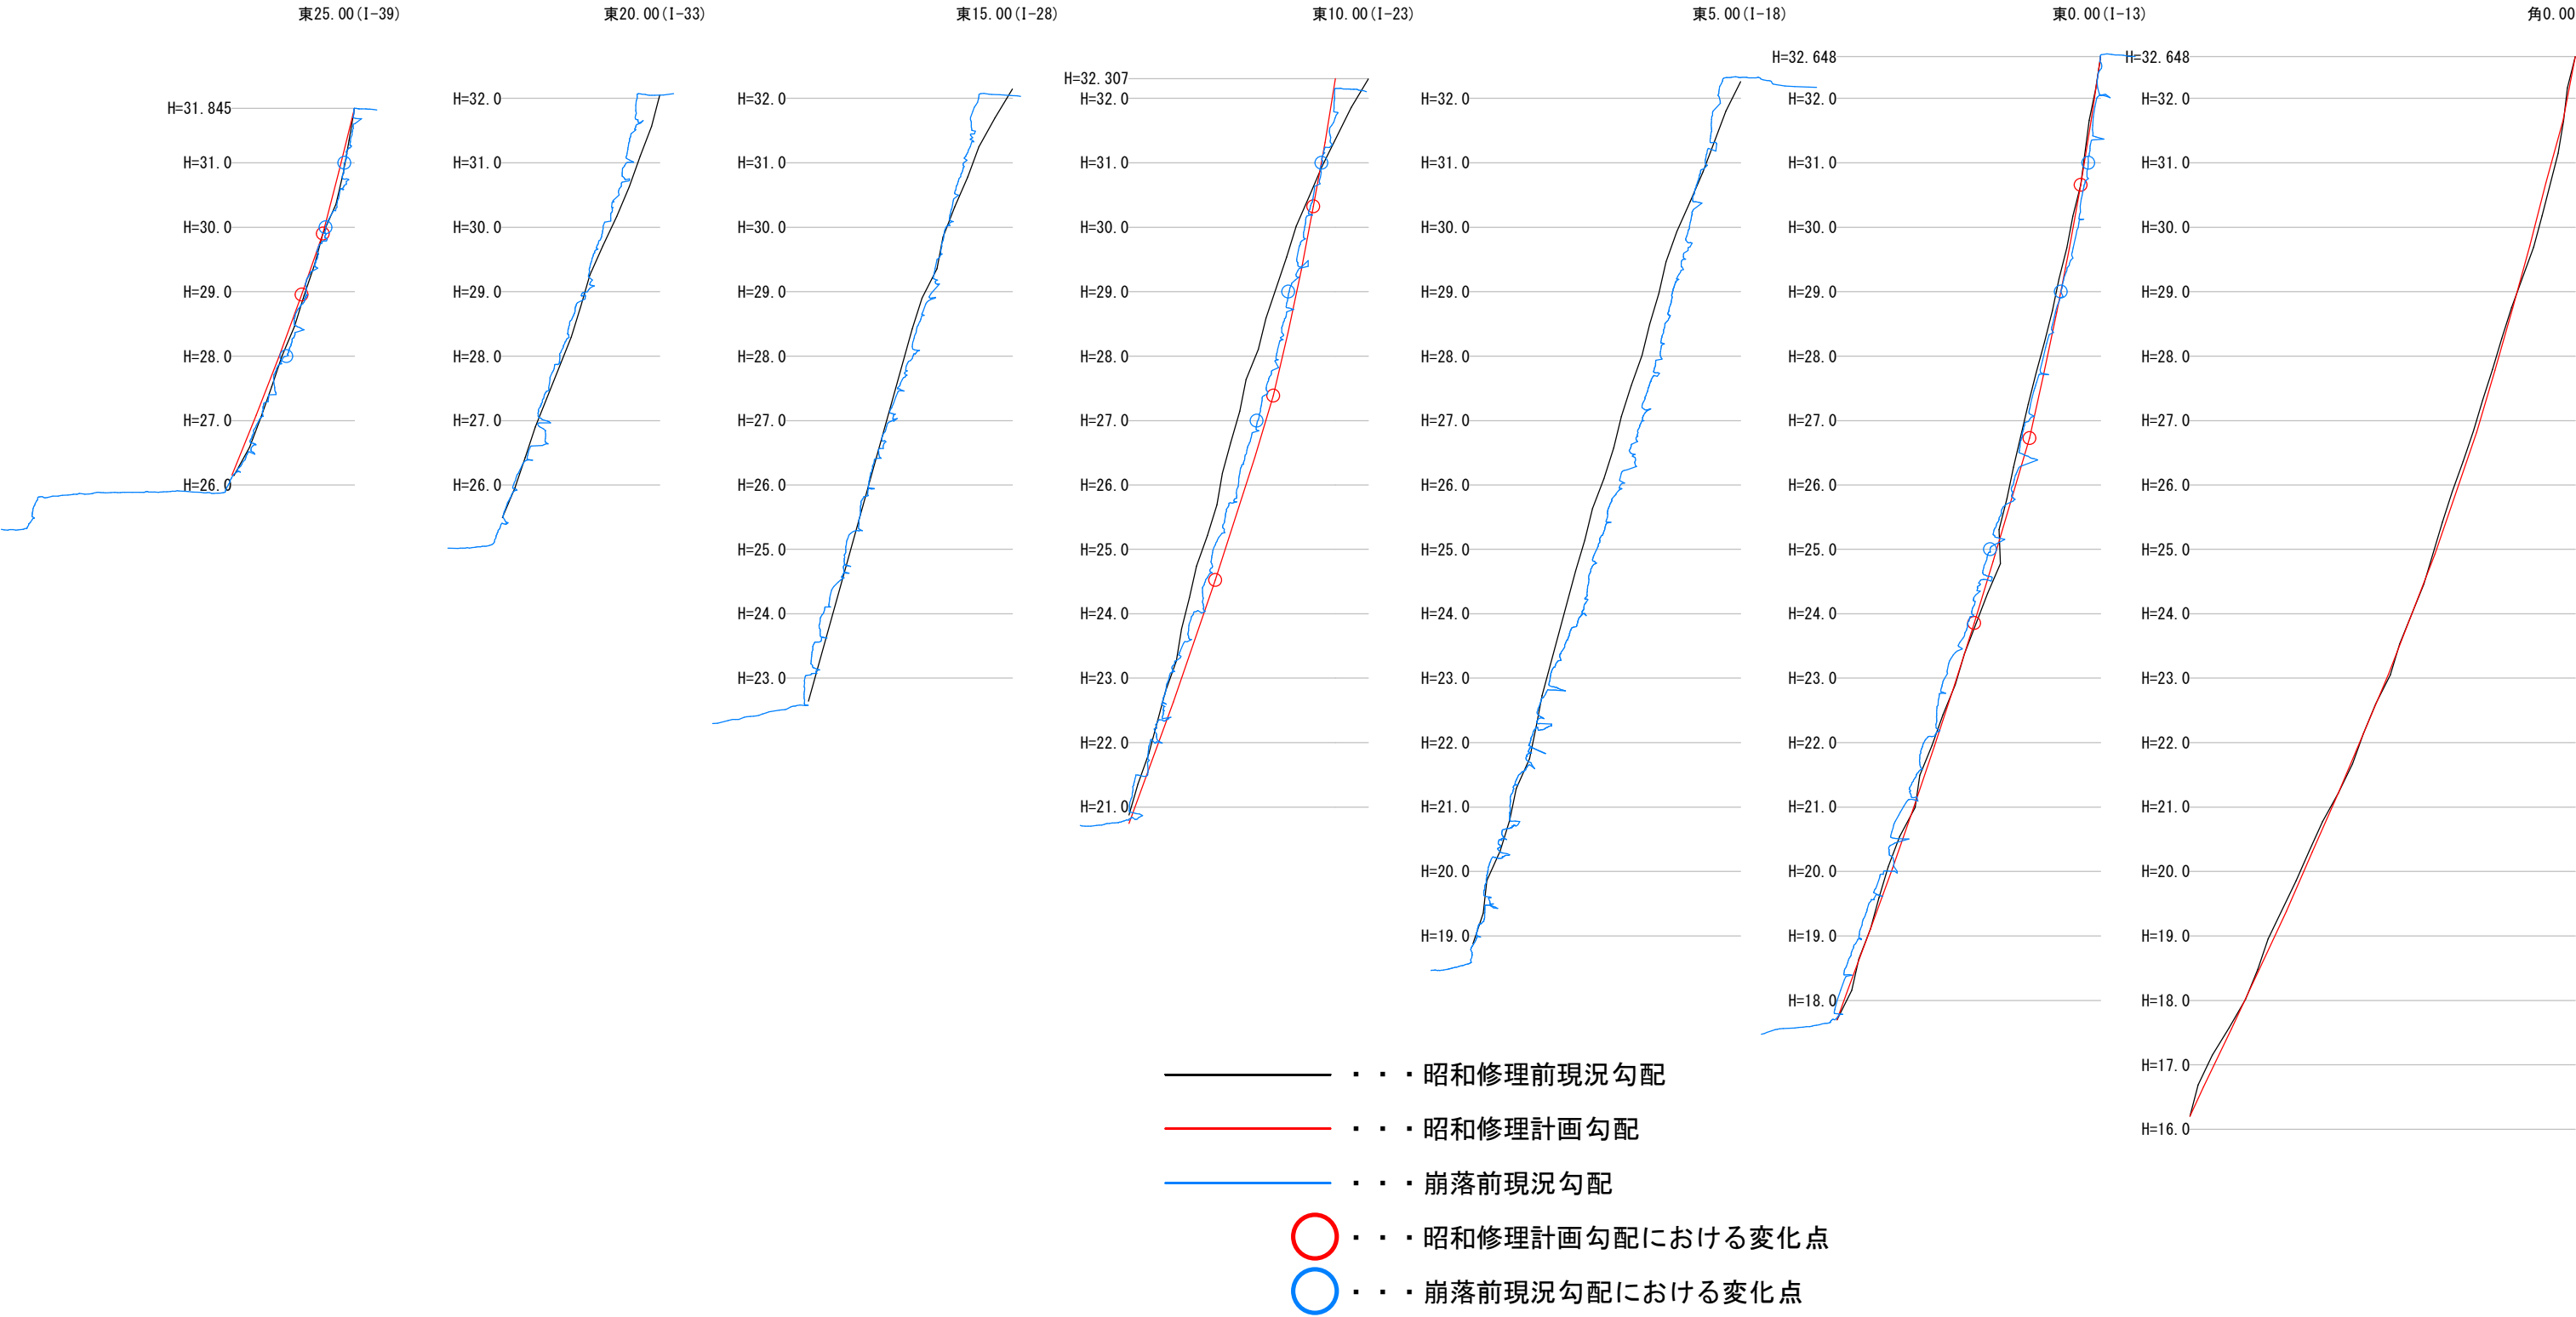
# 各勾配の重ね合わせ図（東面）

昭和修理時の測線の断面図      昭和修理時の測線に対応する崩落前現況勾配

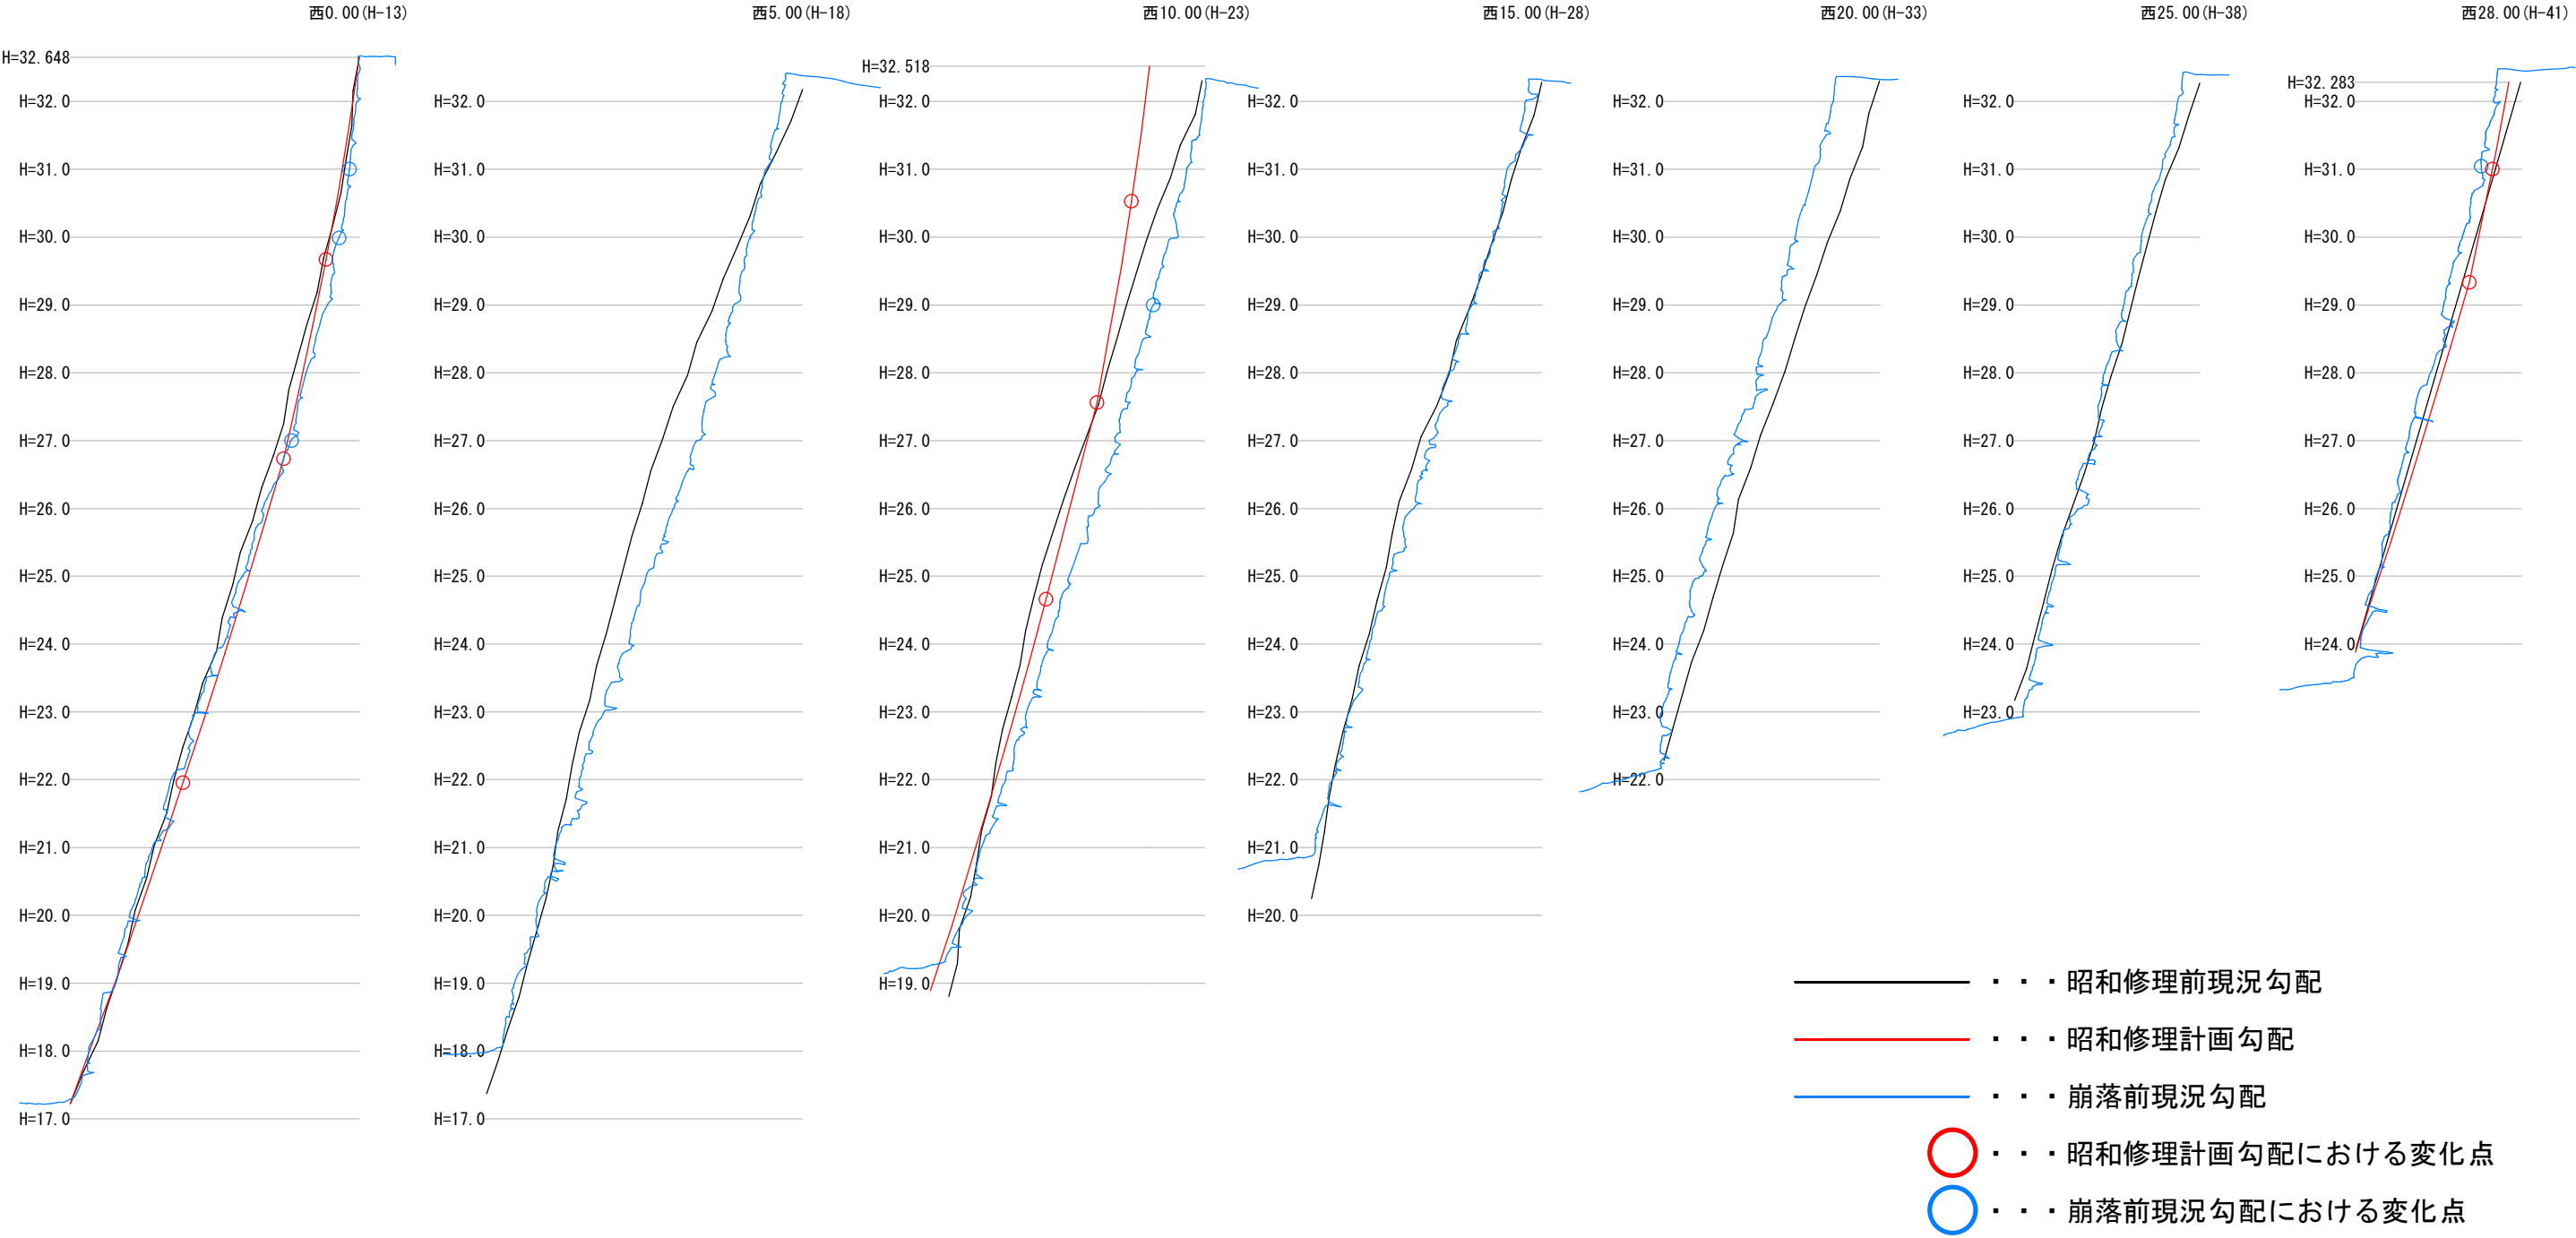
各勾配の重ね合わせ図（西面）

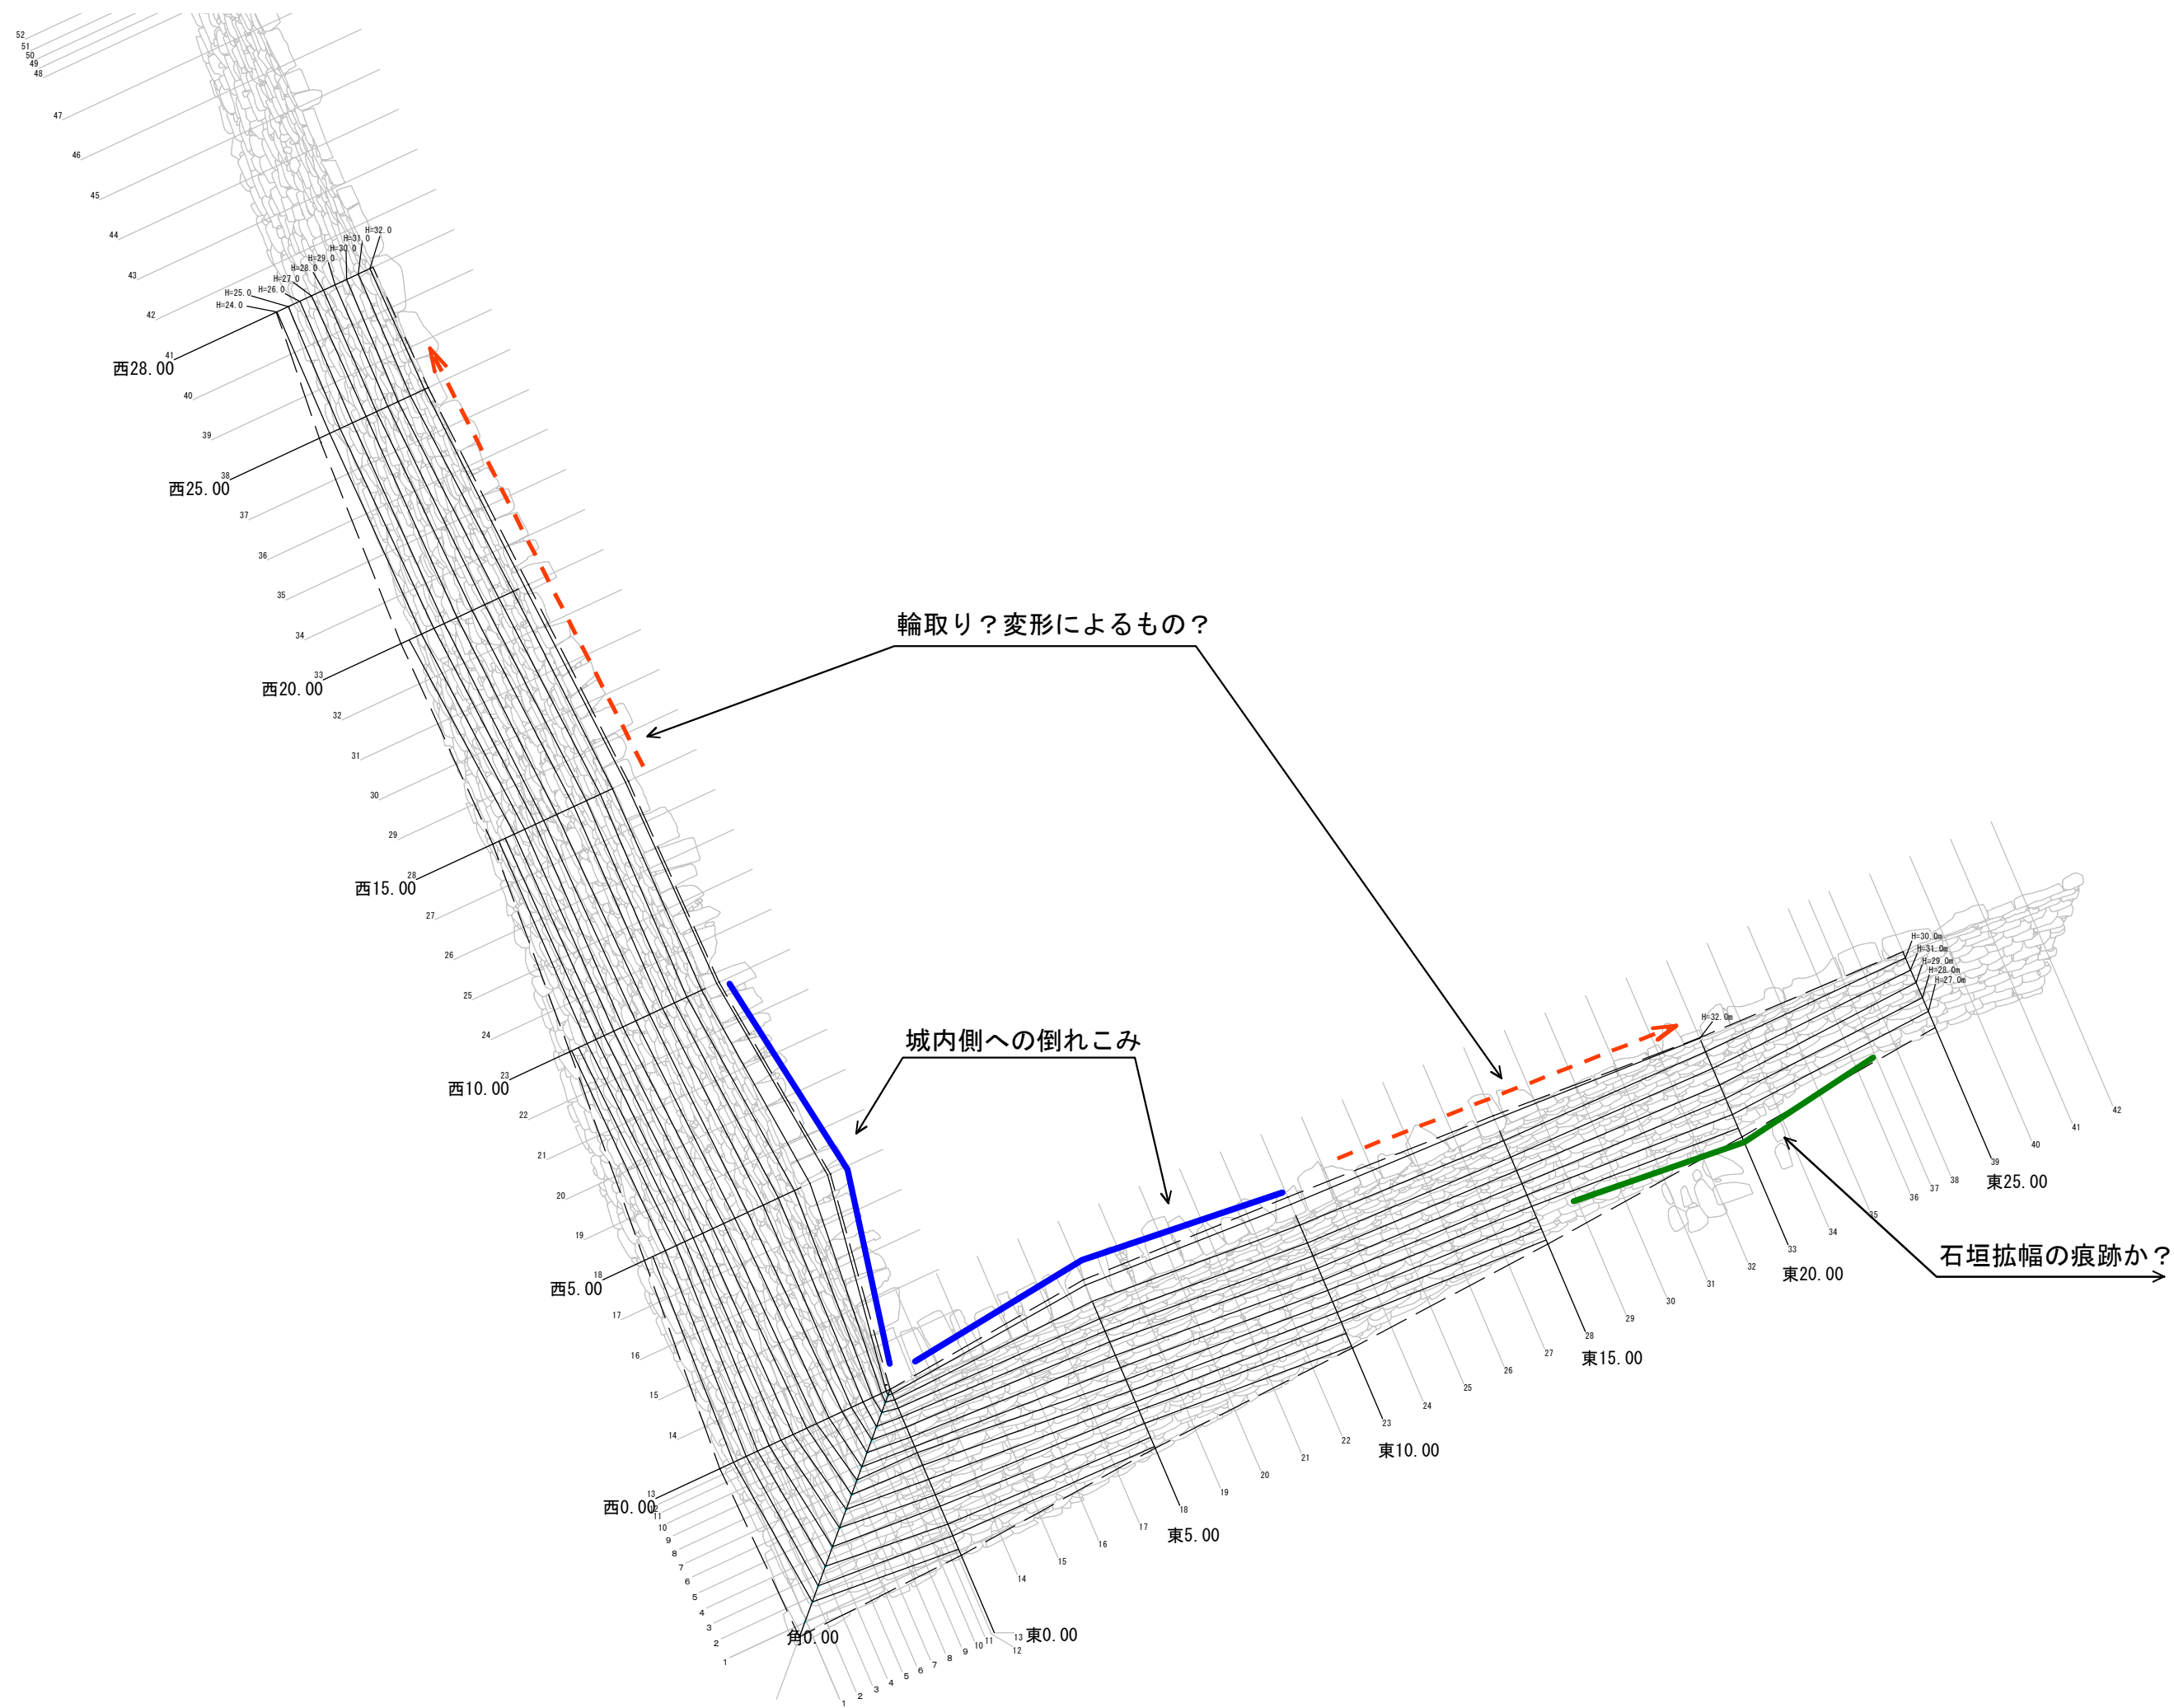
東面（I面）西面（H面）昭和修理前復元平面図

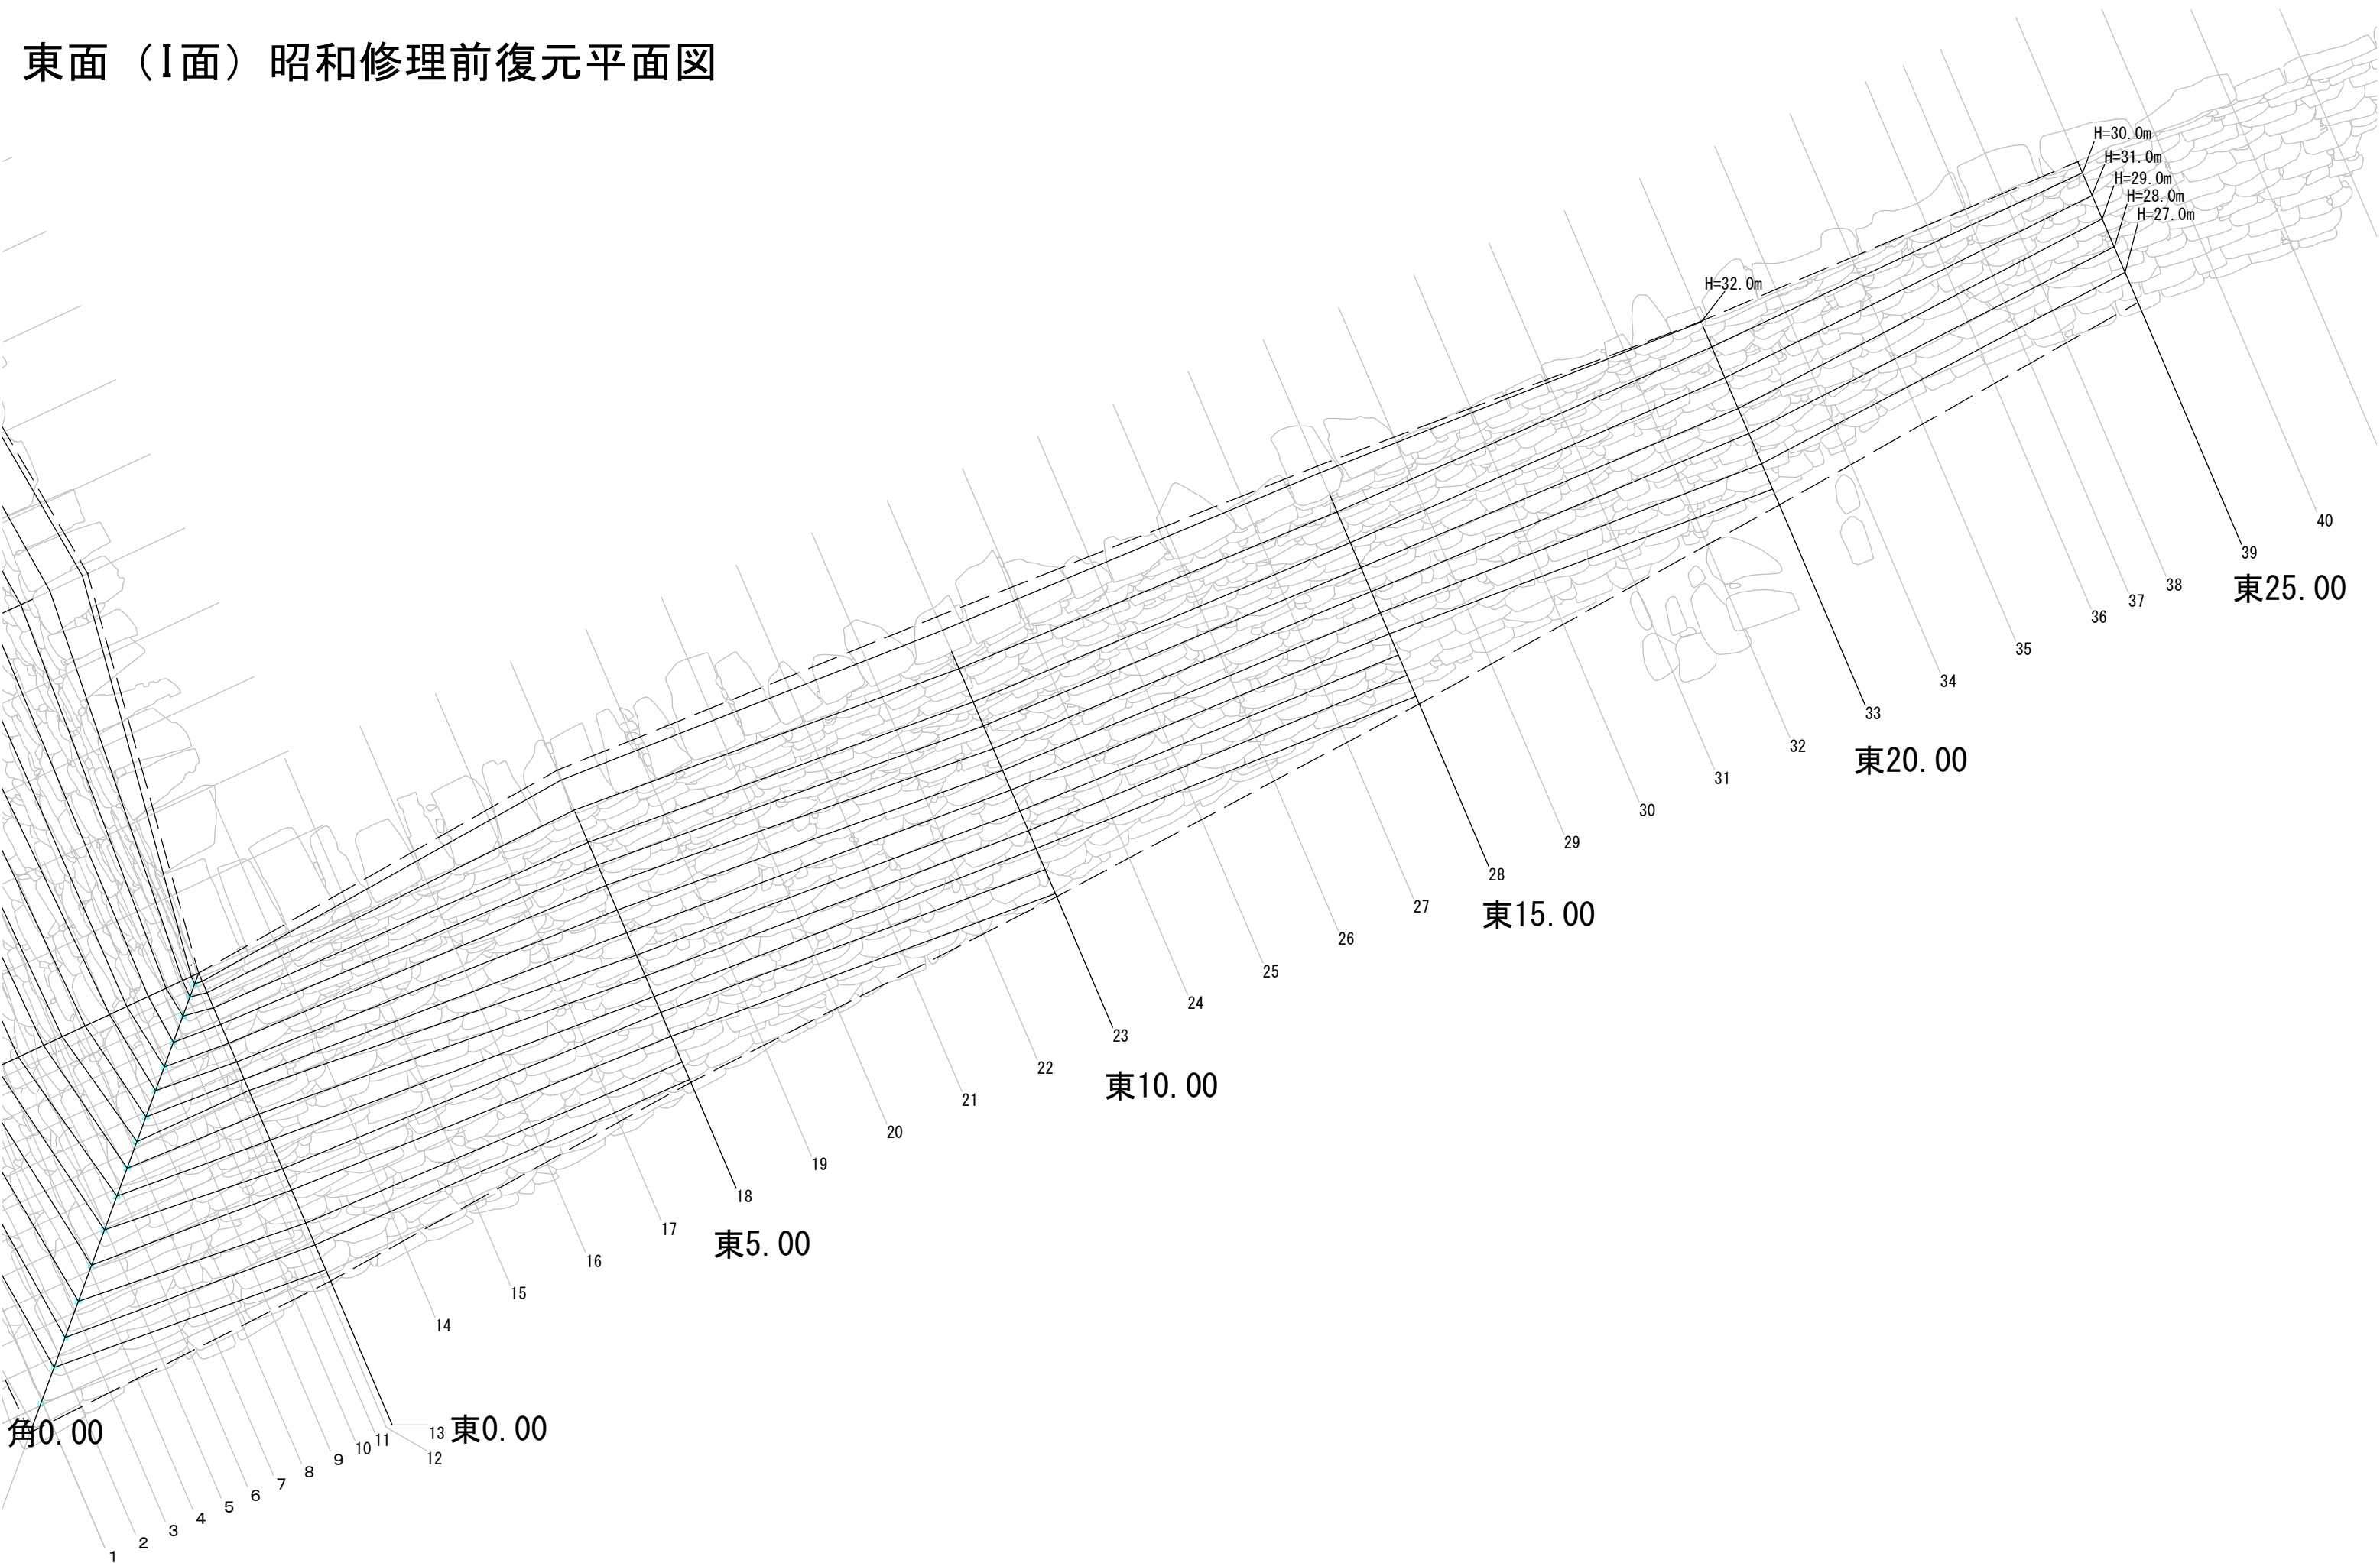
東面（I面）昭和修理前復元平面図
