丸亀城石垣の勾配

帶曲輪石垣（H面、I面）崩落前平面図

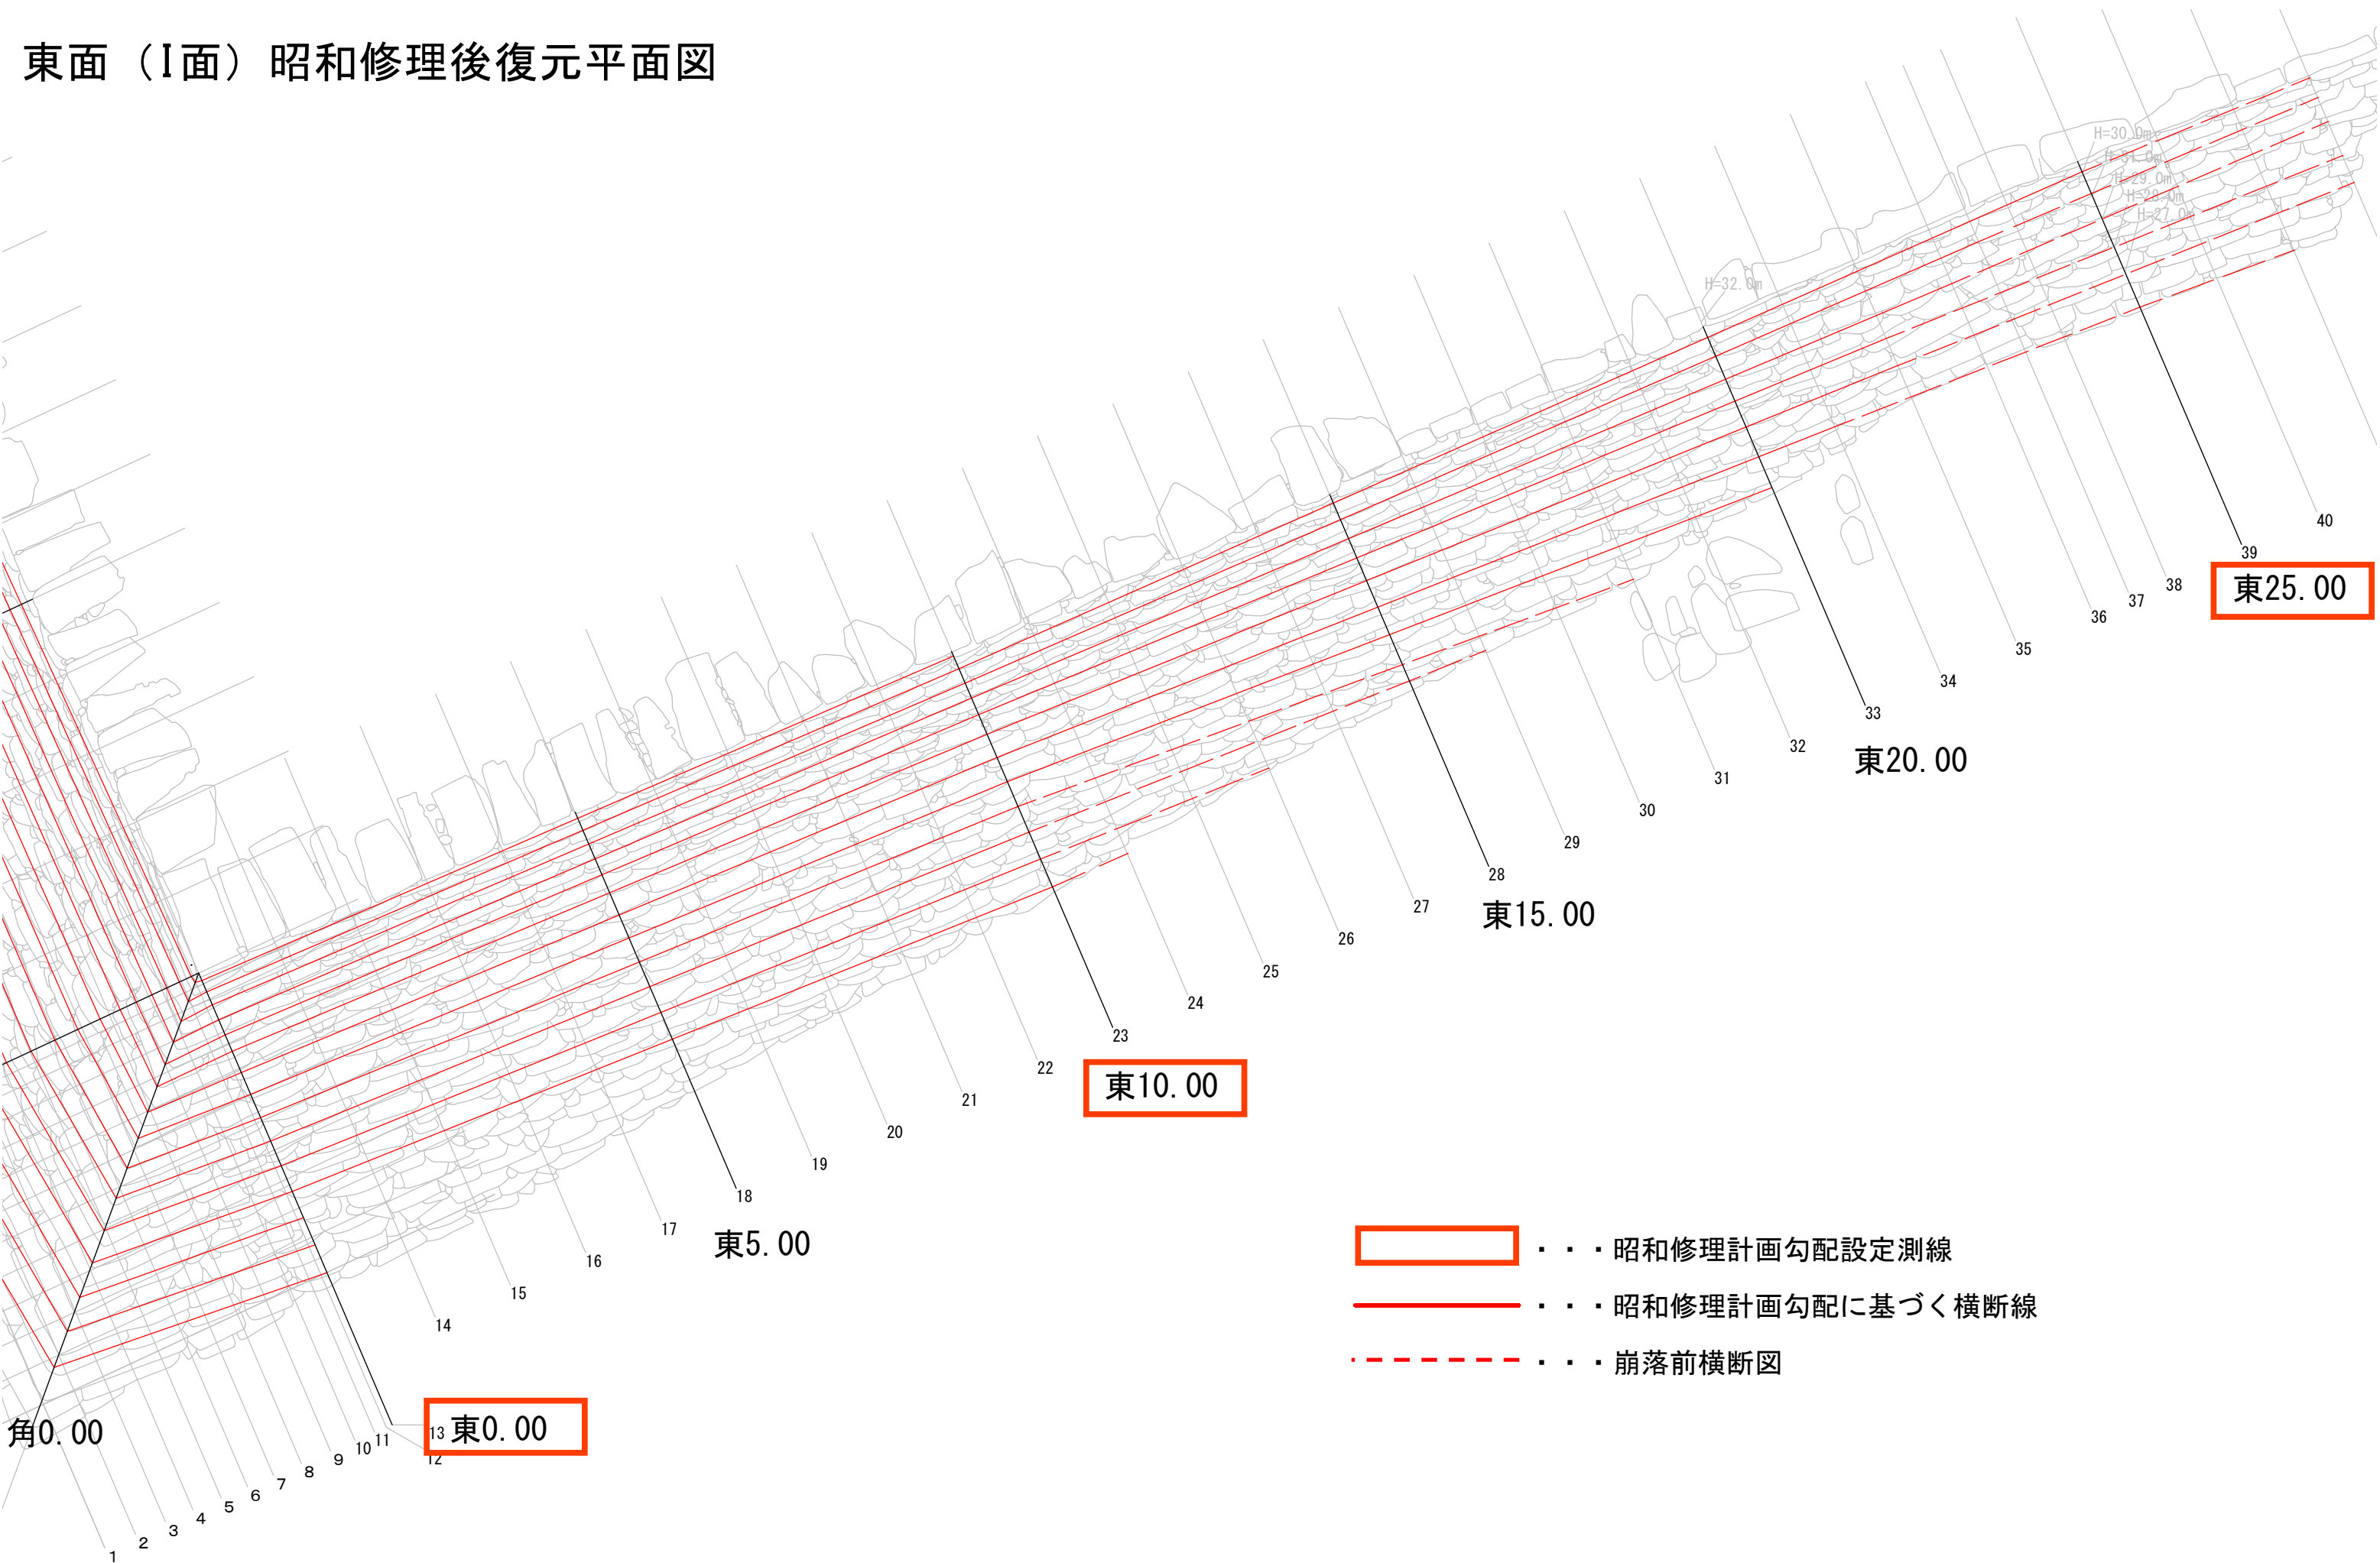
東面（I面）昭和修理後復元平面図

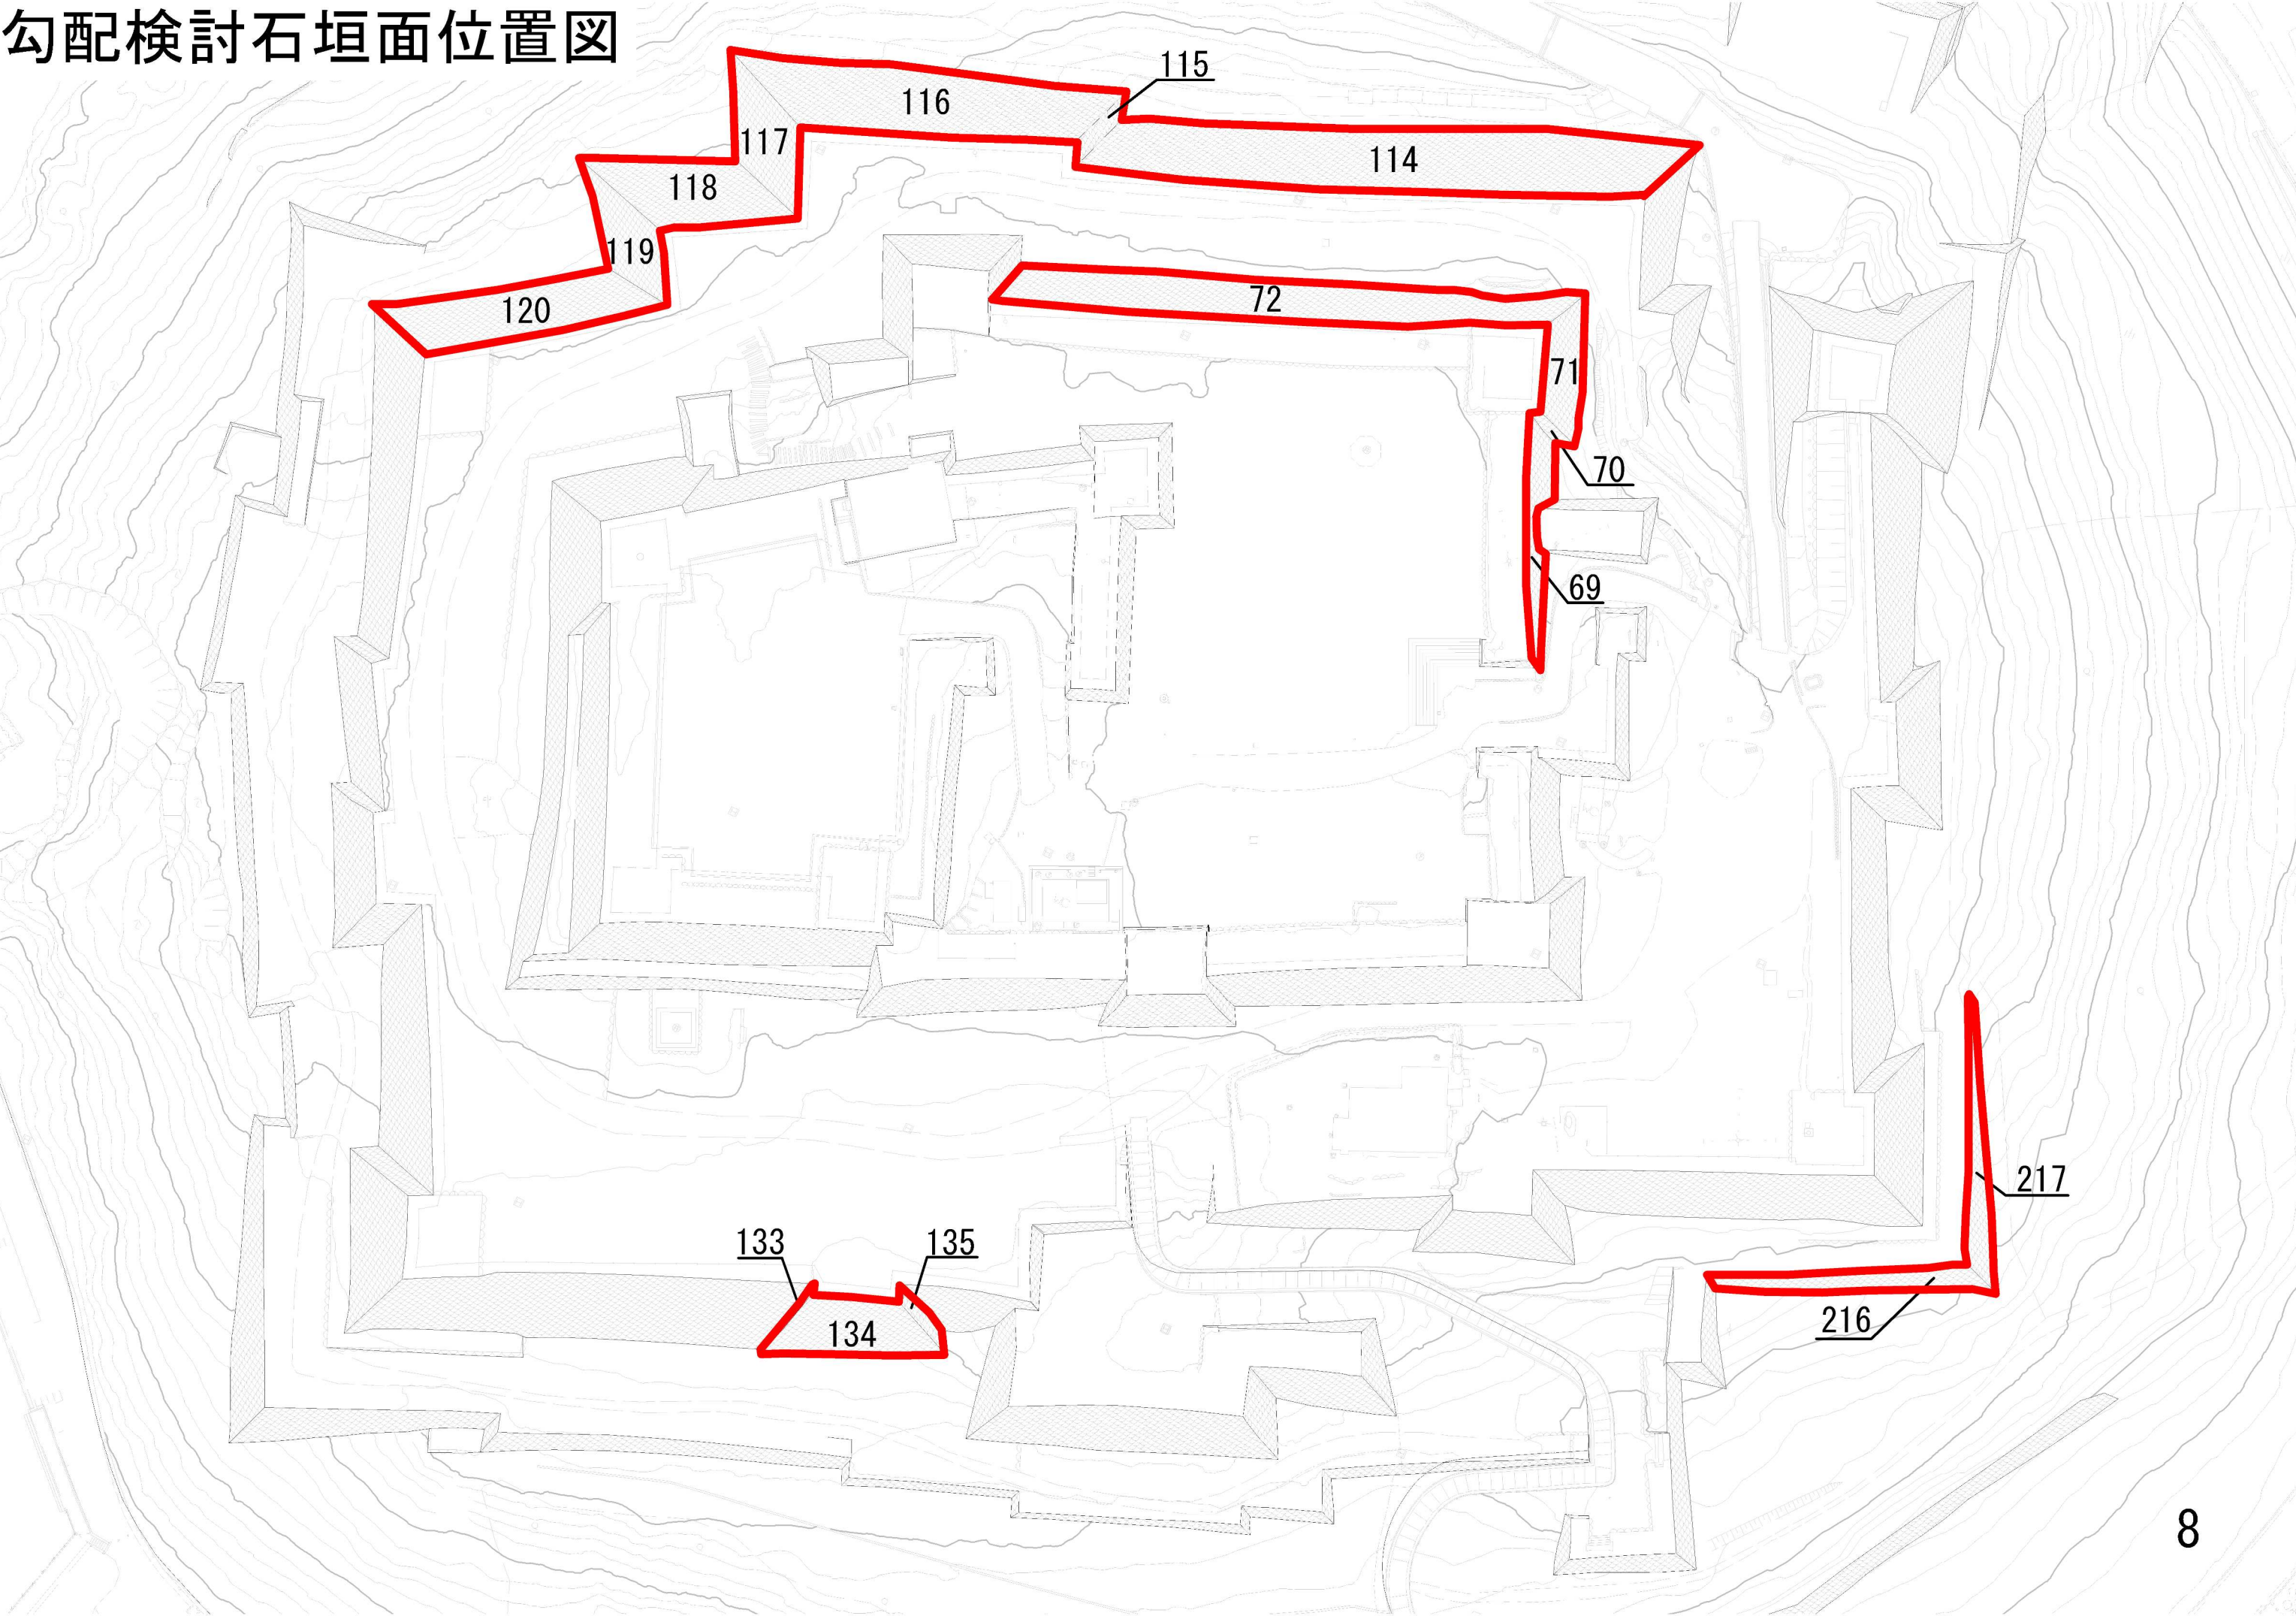
勾配検討石垣面位置図

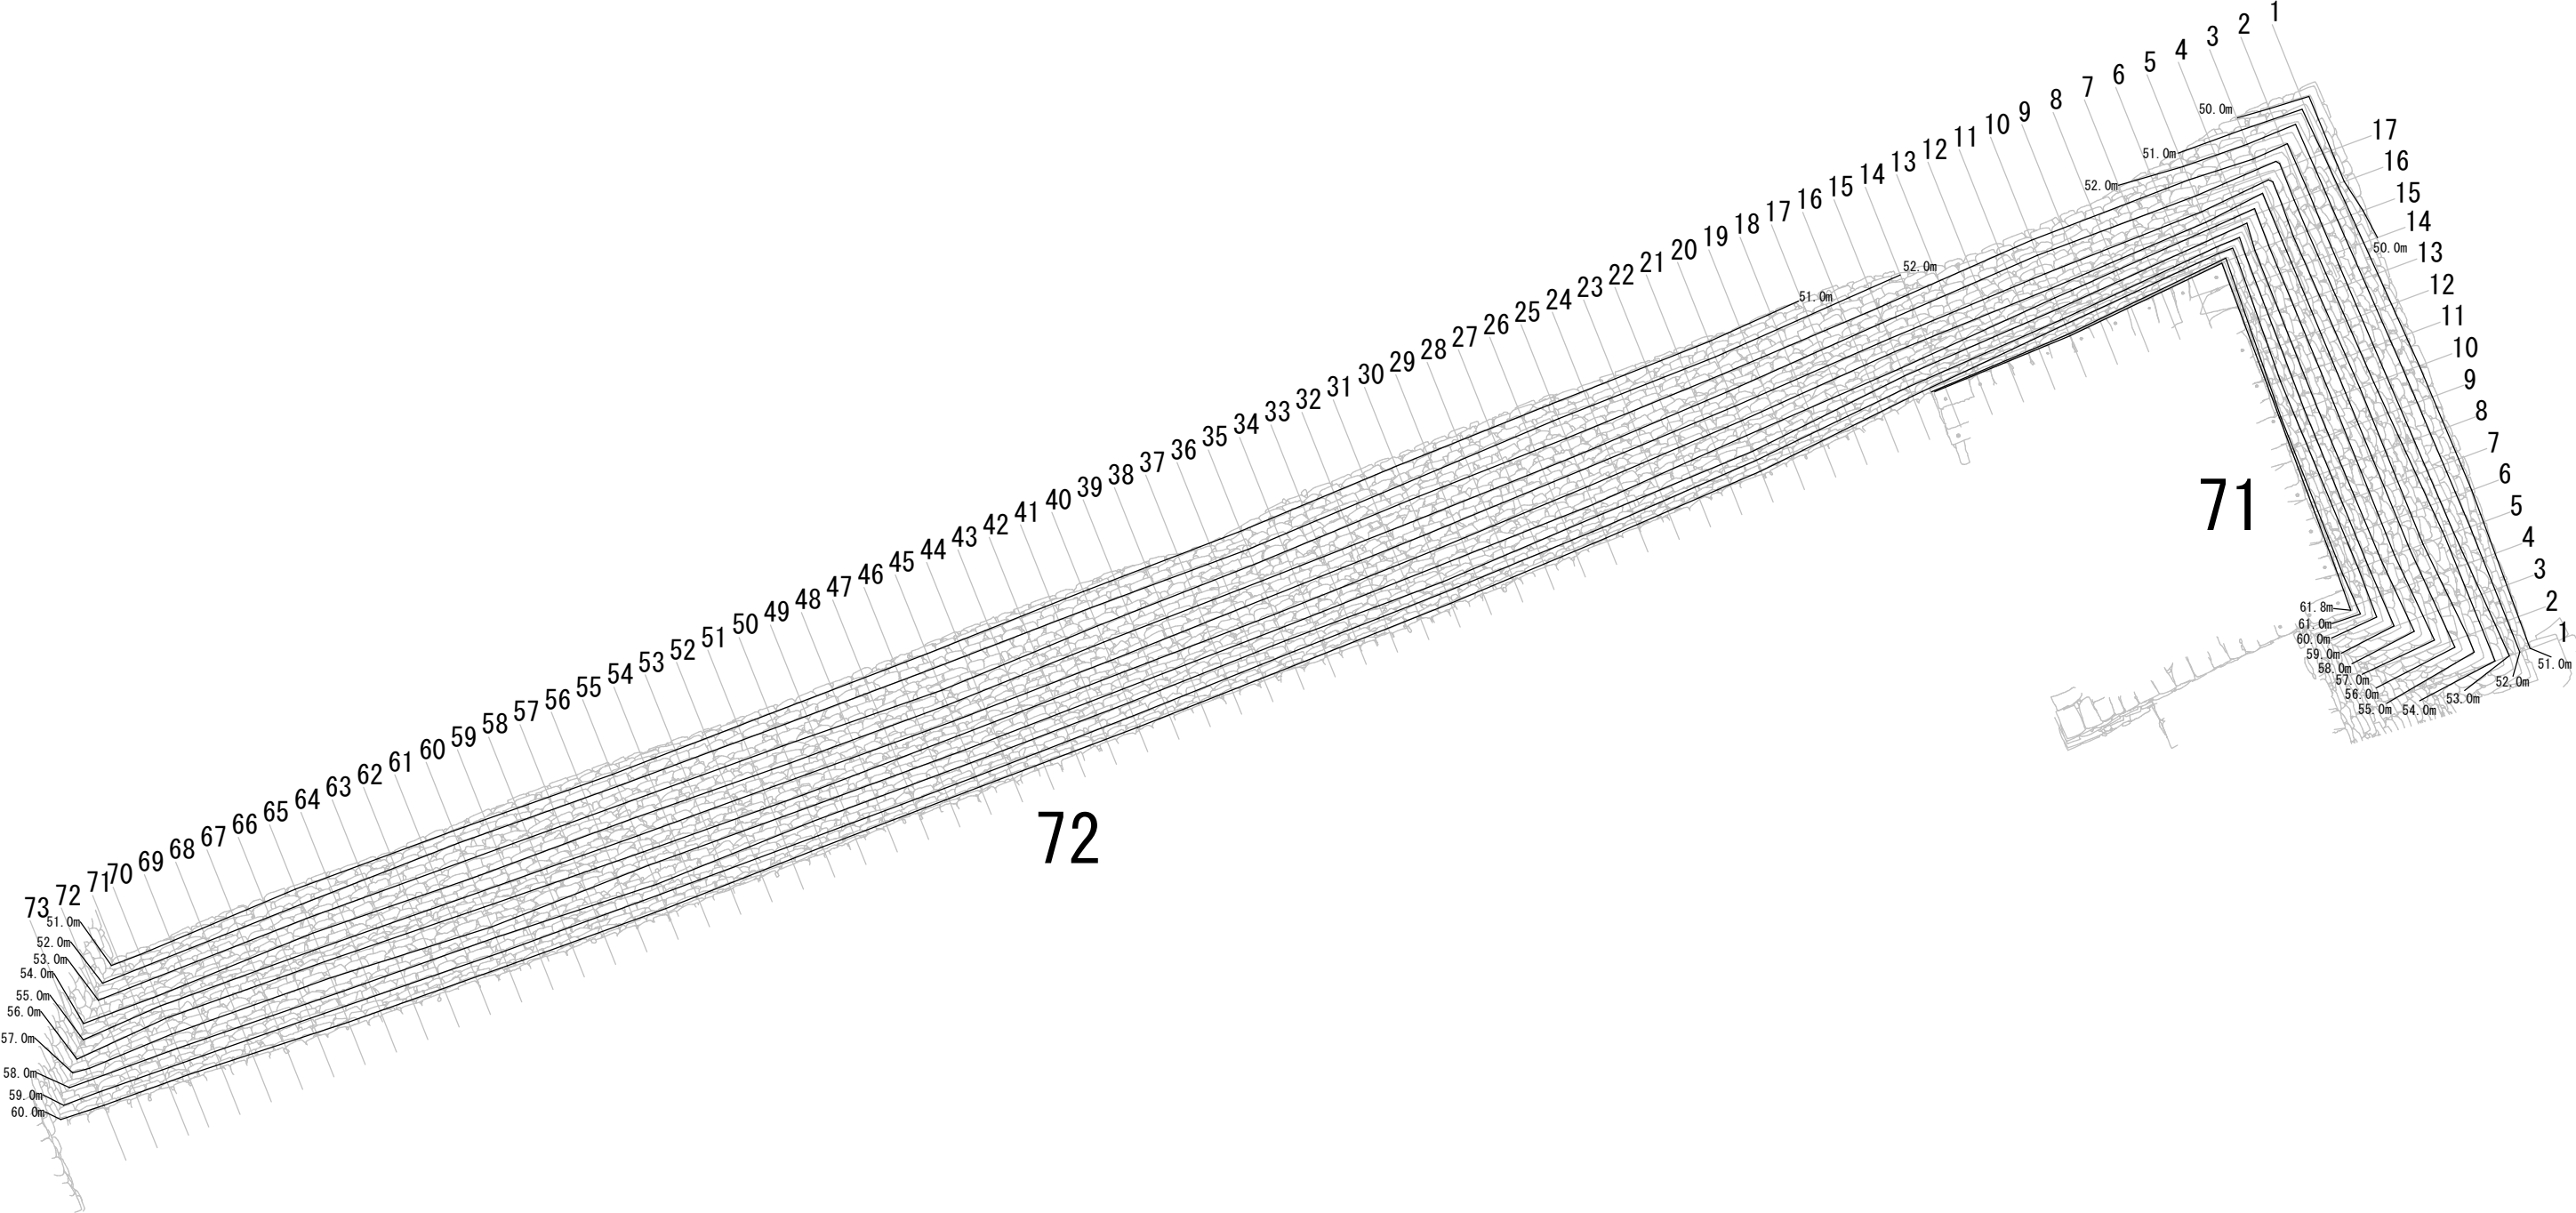
71面、72面平面図

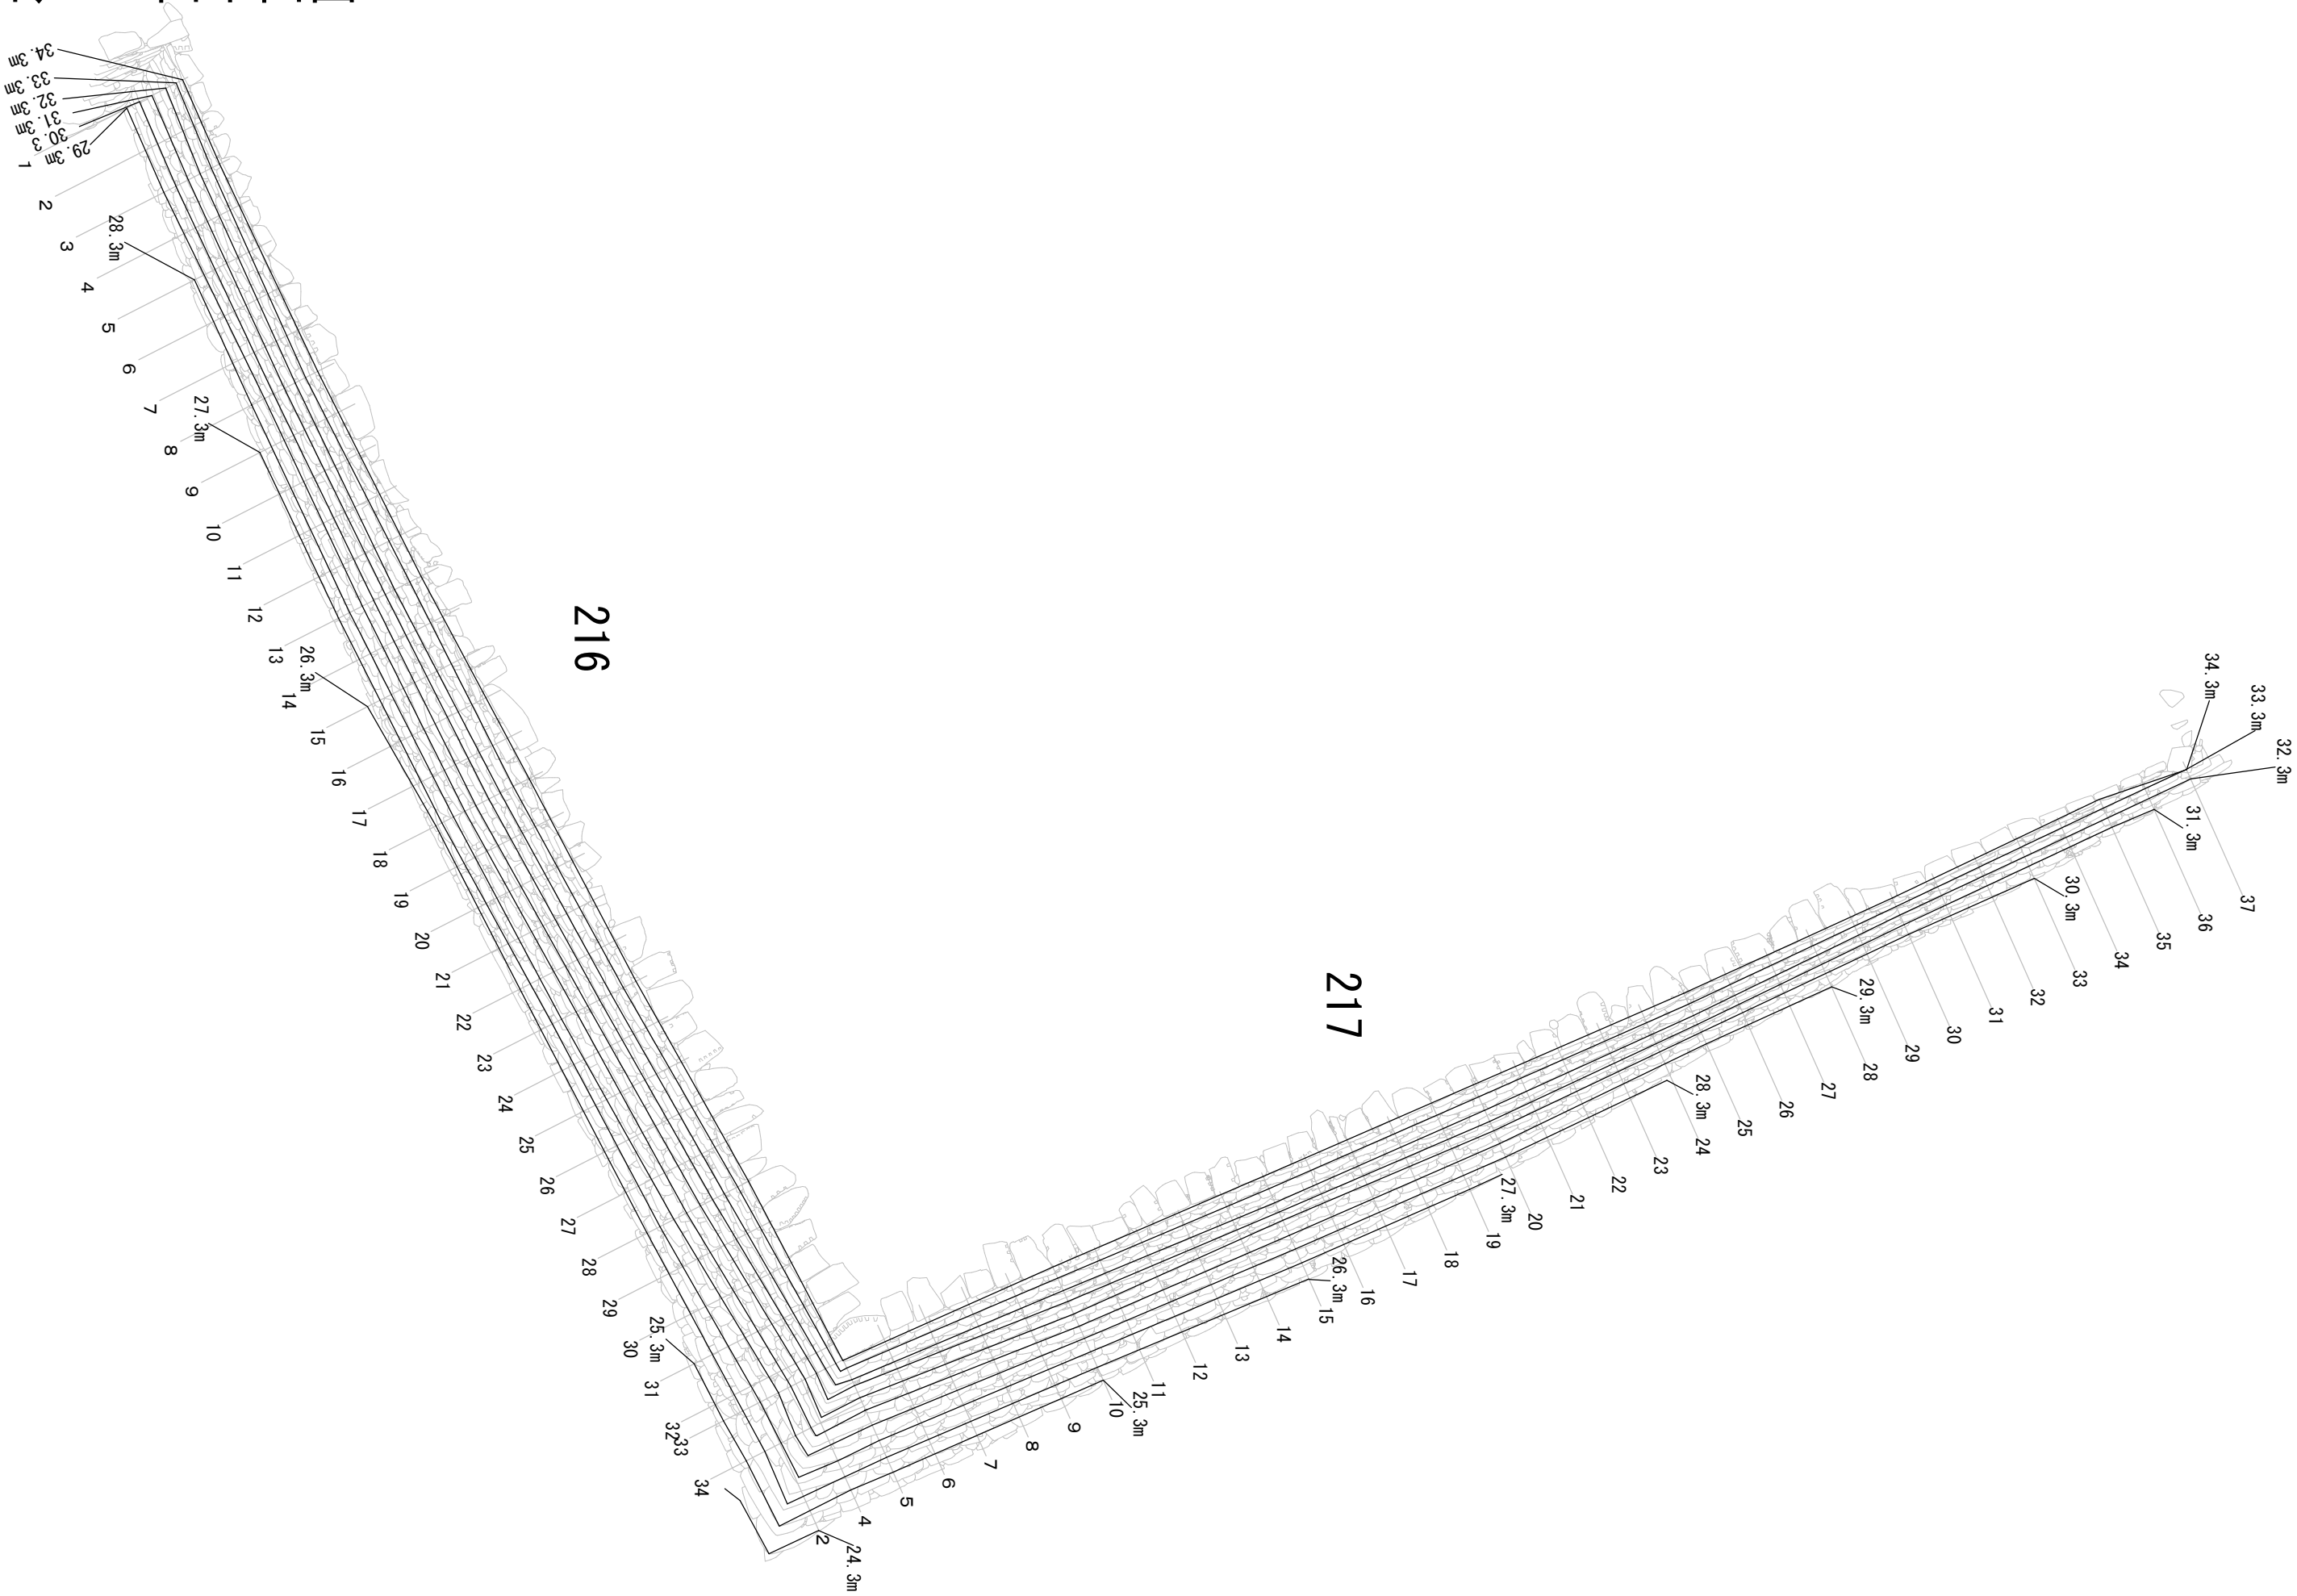
216面、217面平面図

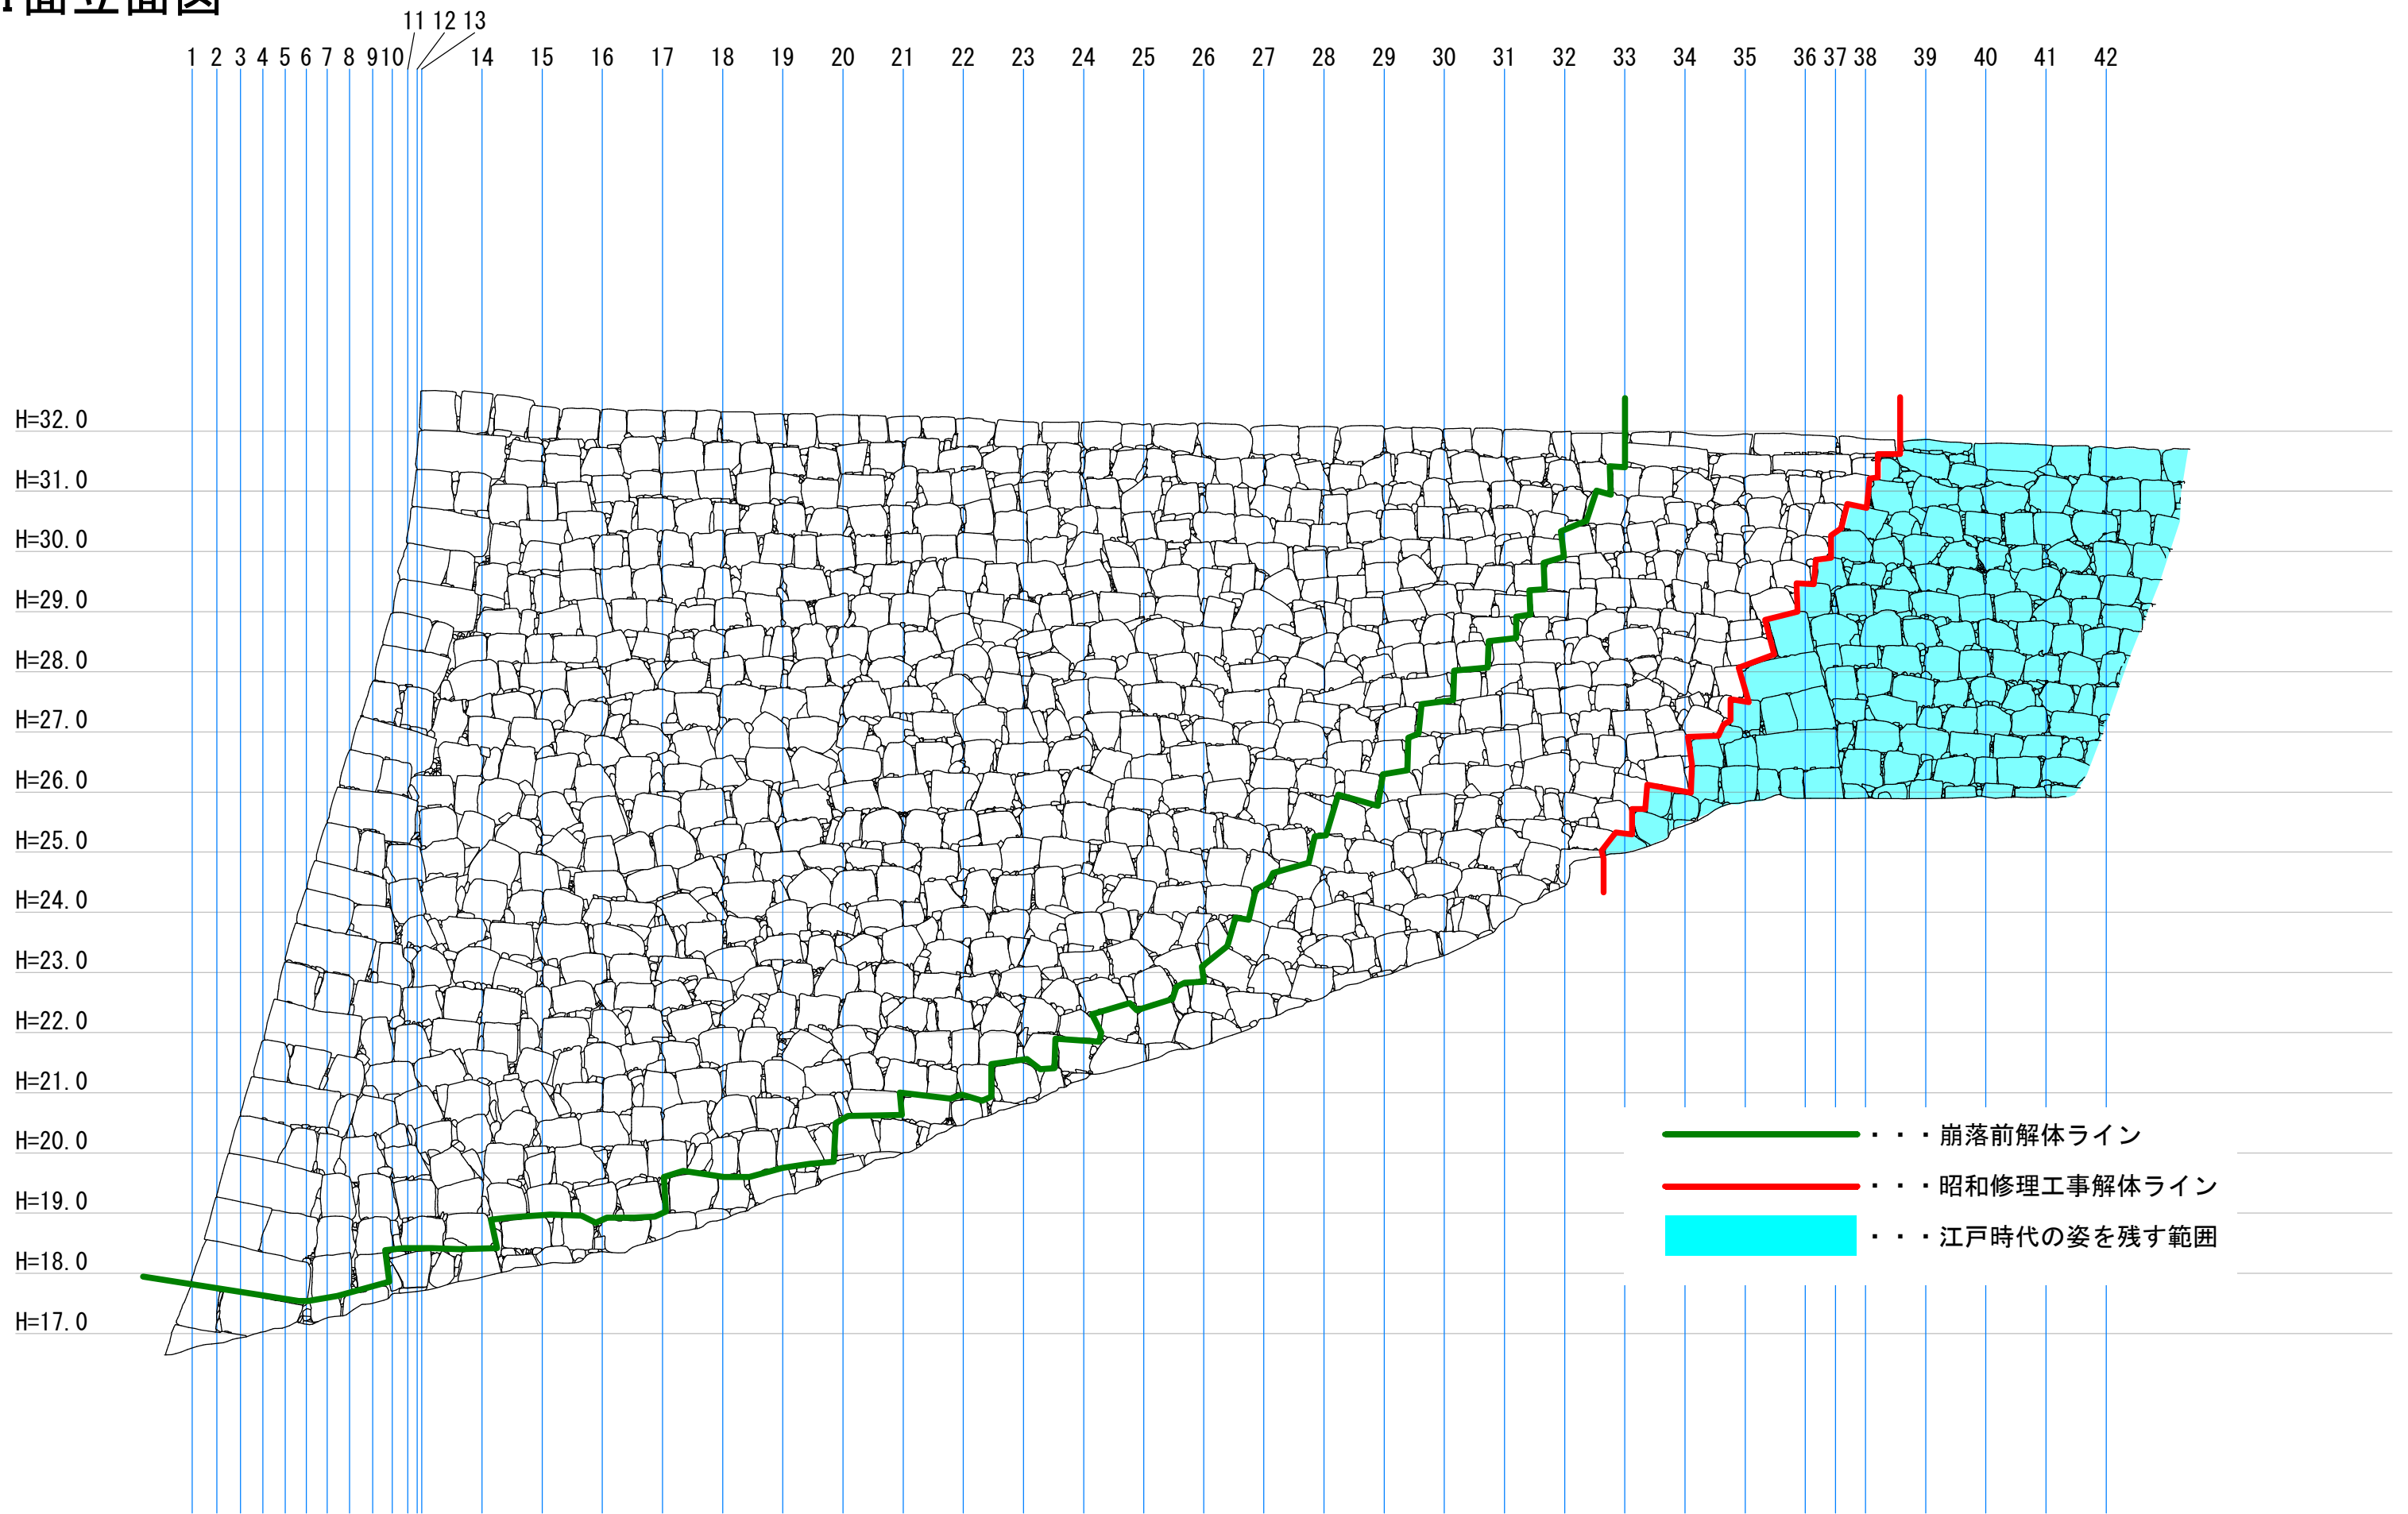
I面立面図

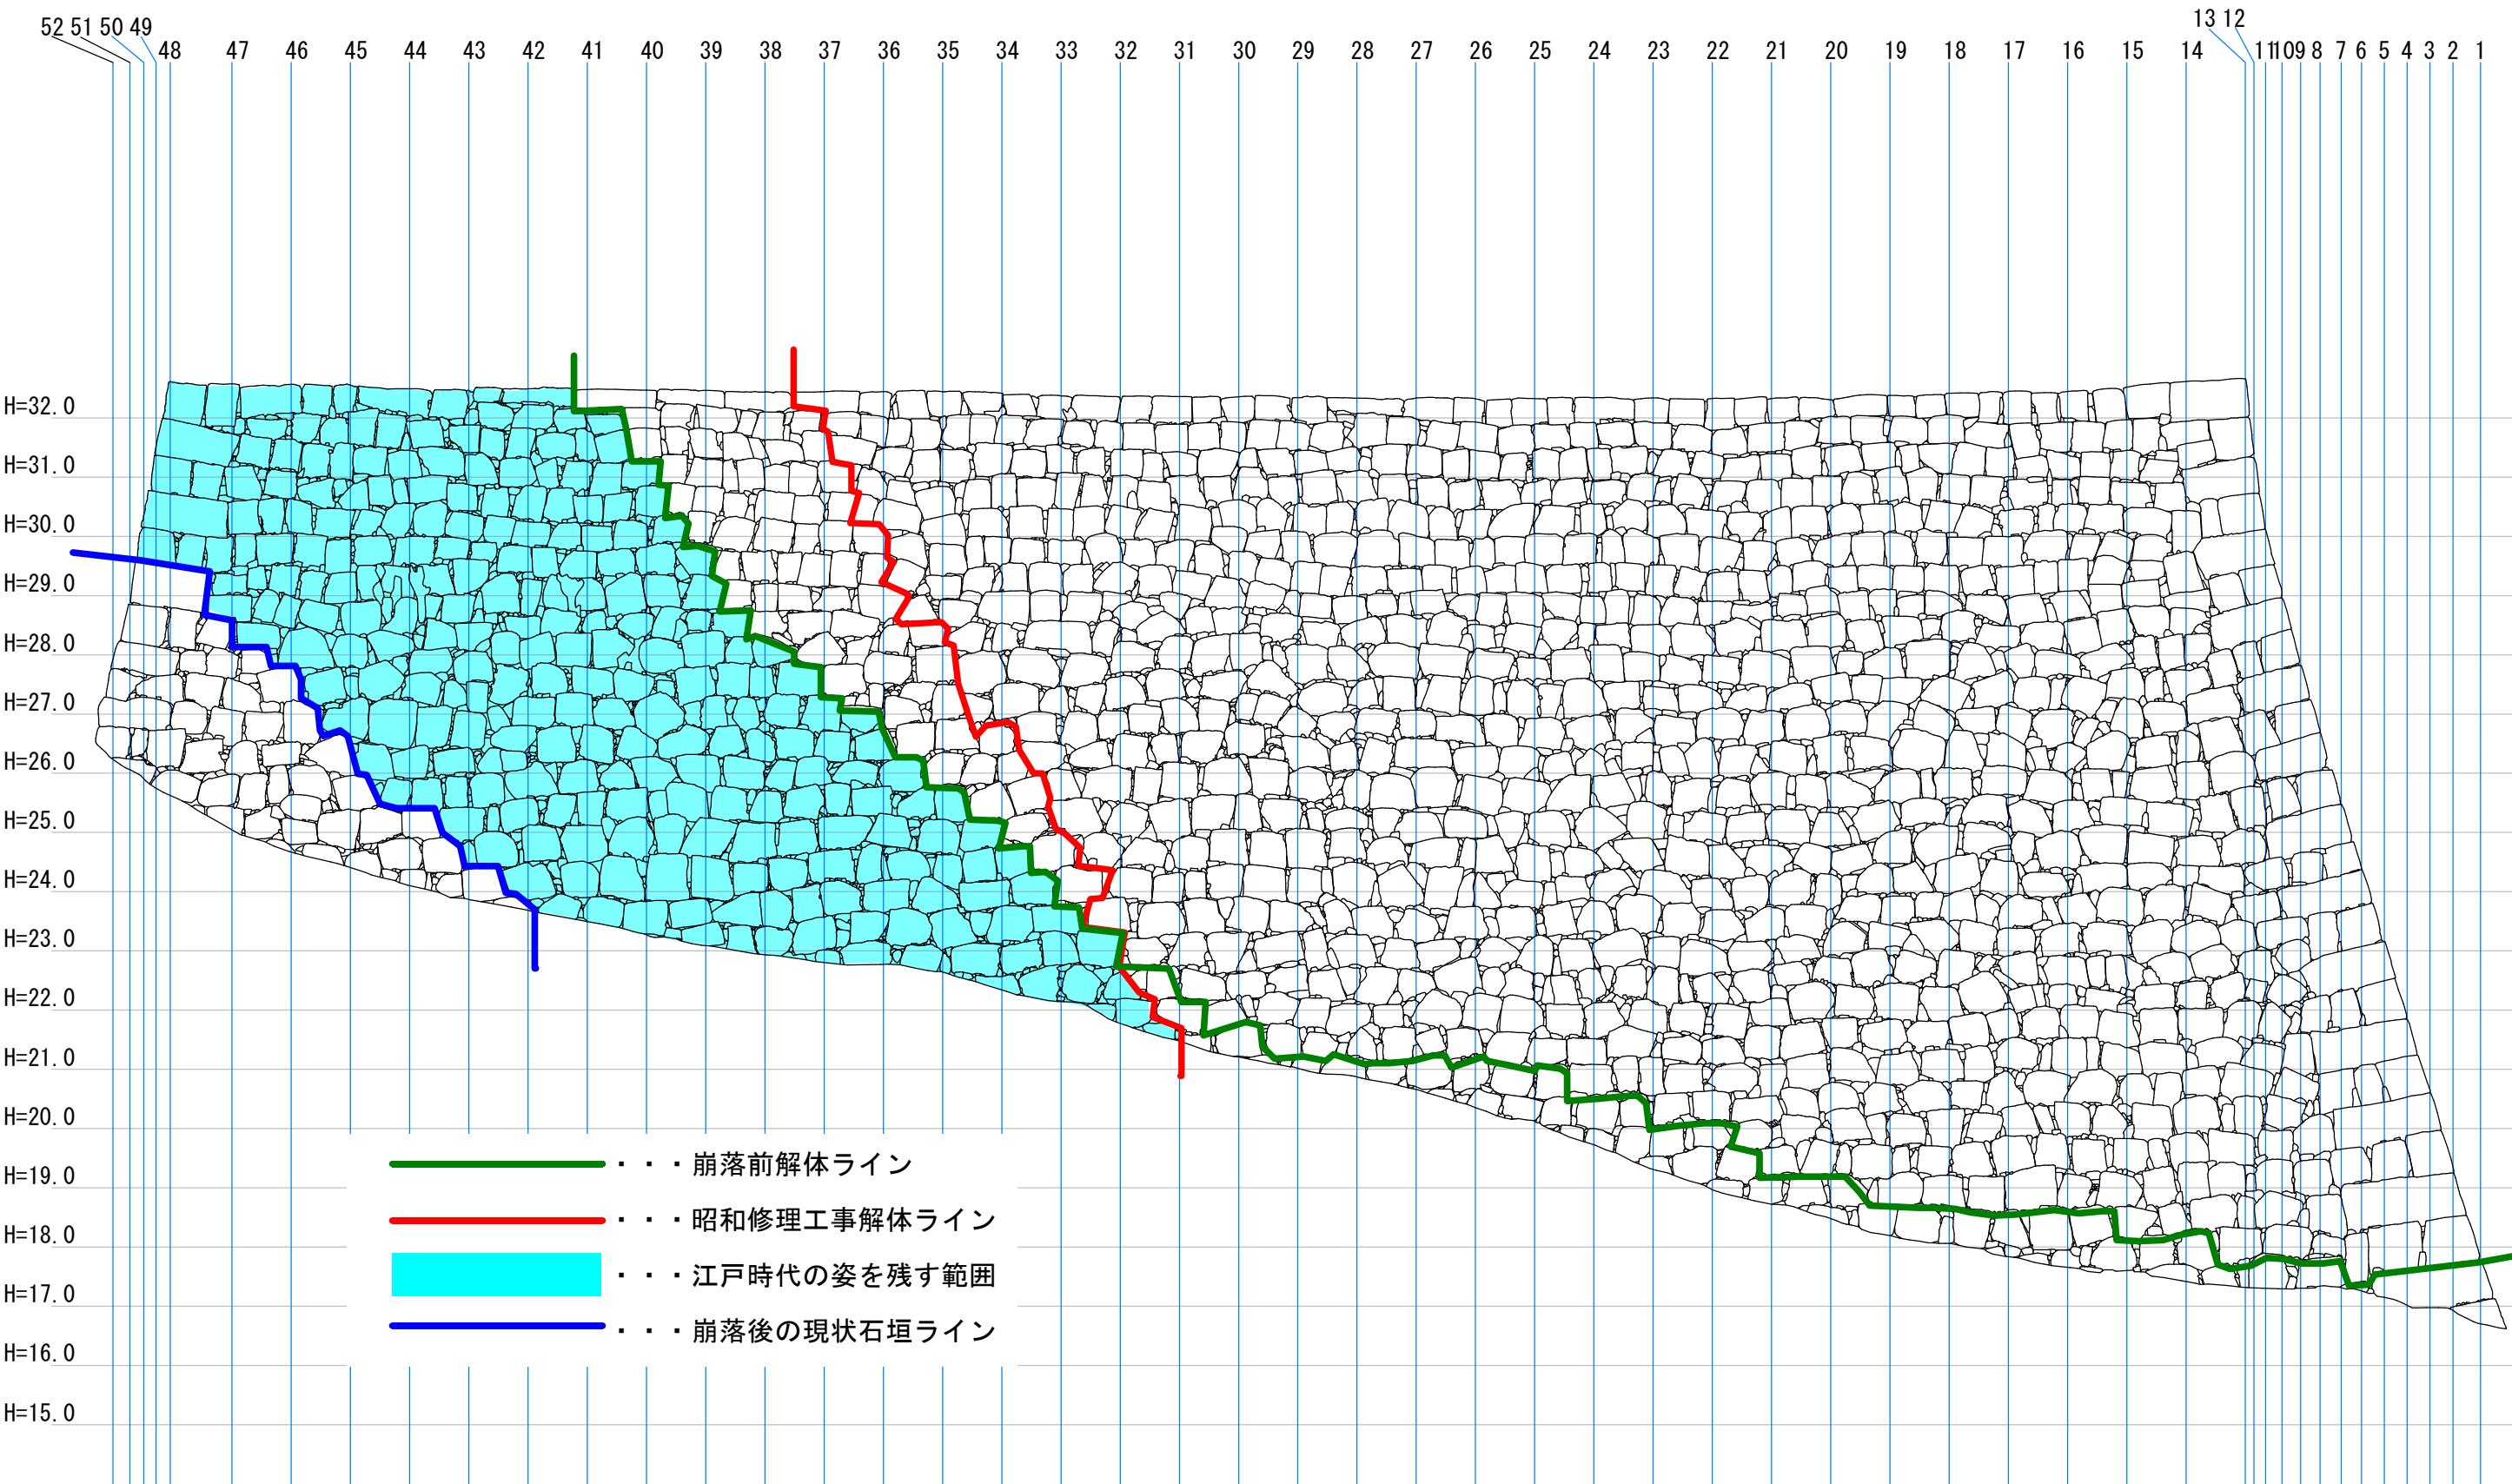
H面立面図
