丸亀城石垣の勾配

帶曲輪石垣（H面、I面）崩落前平面図

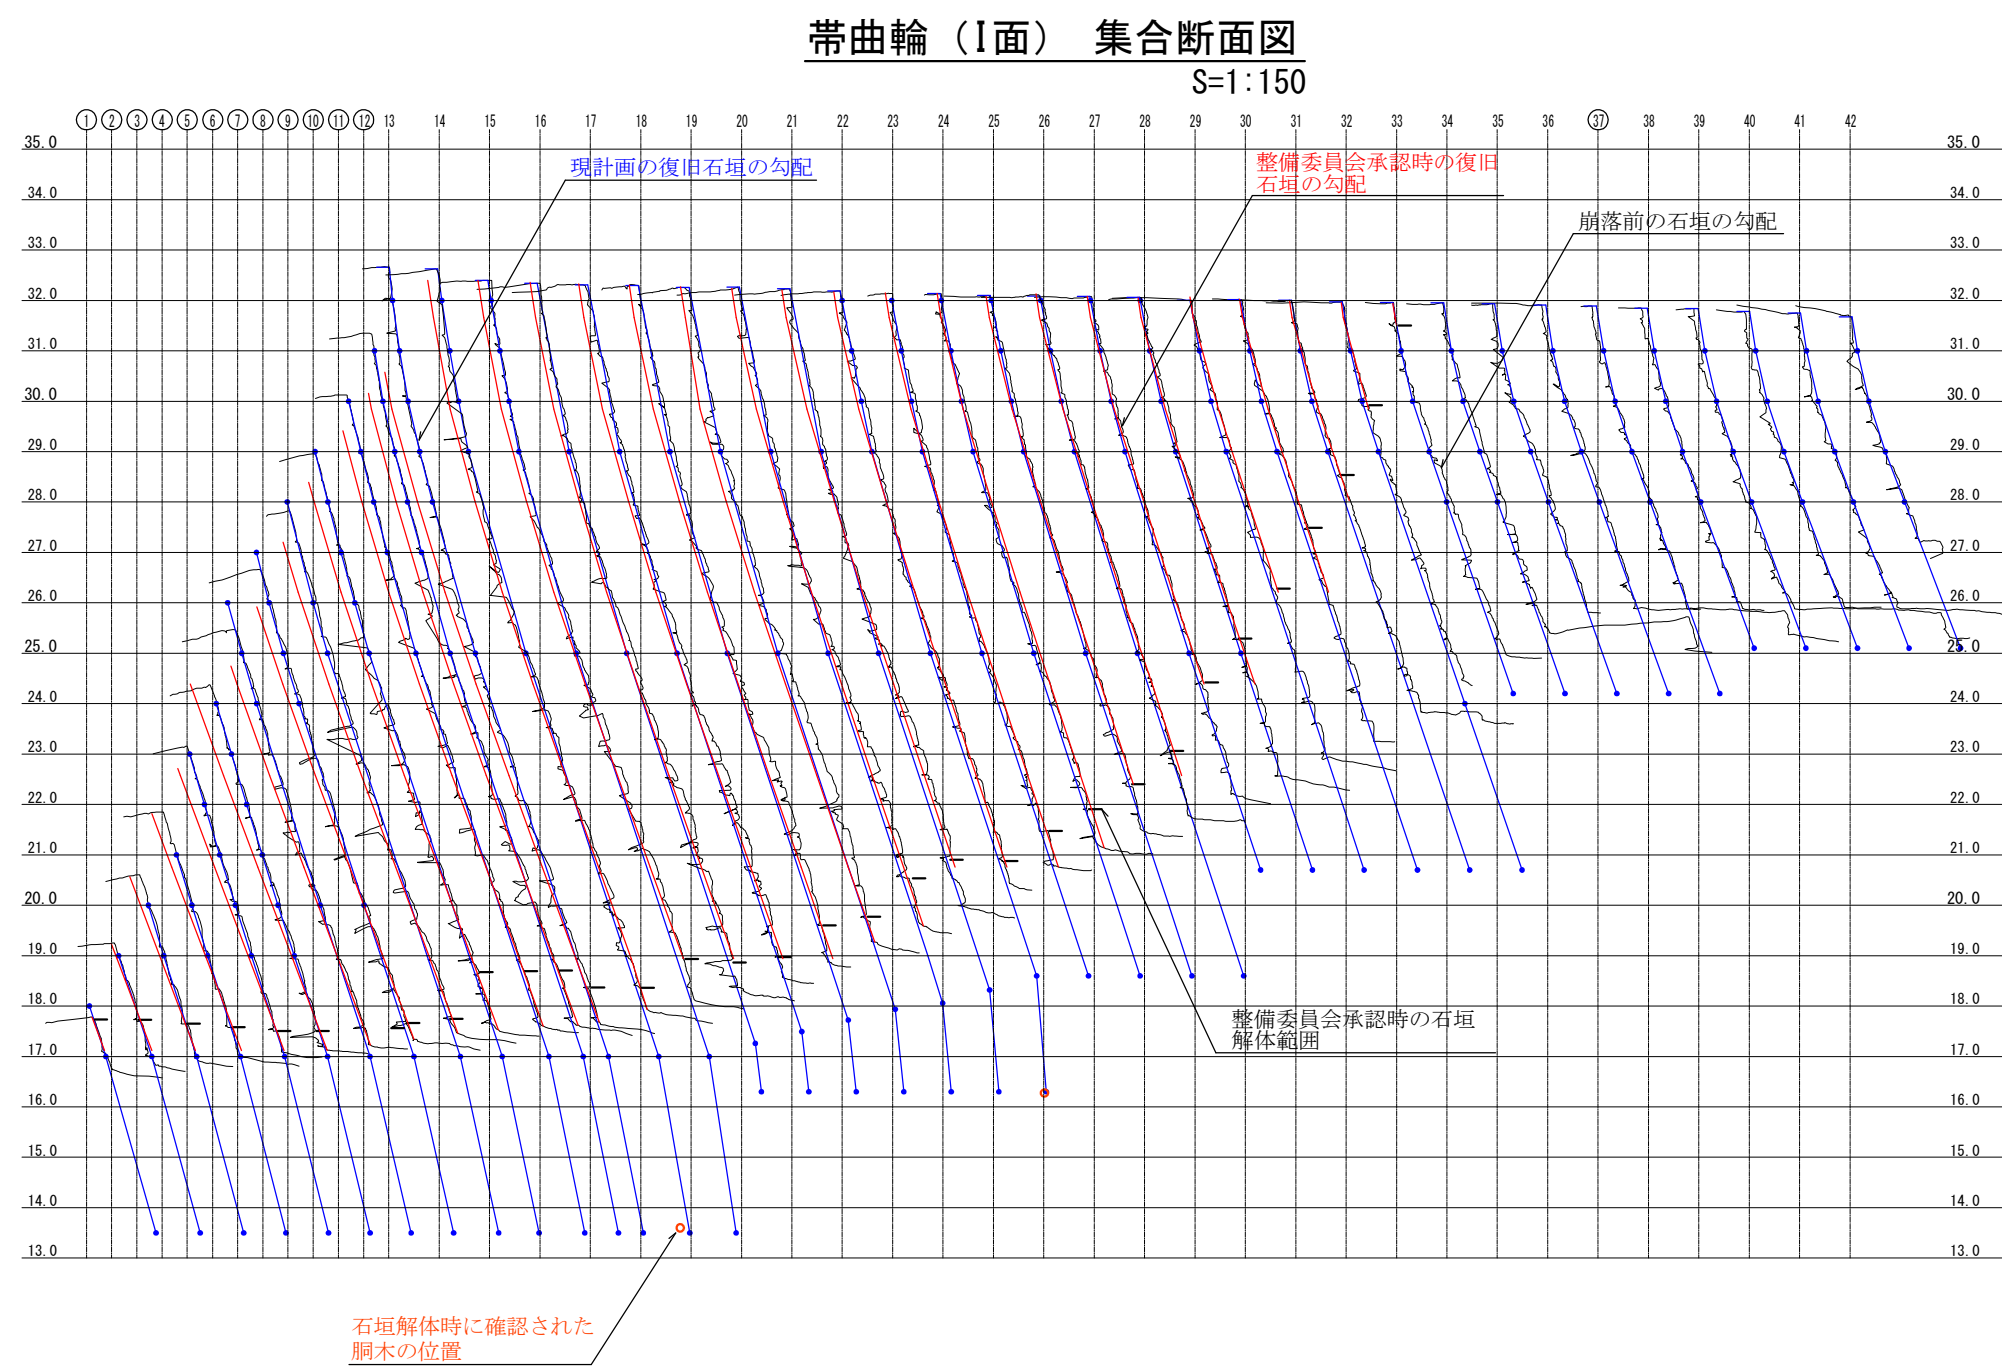
I面集合断面図

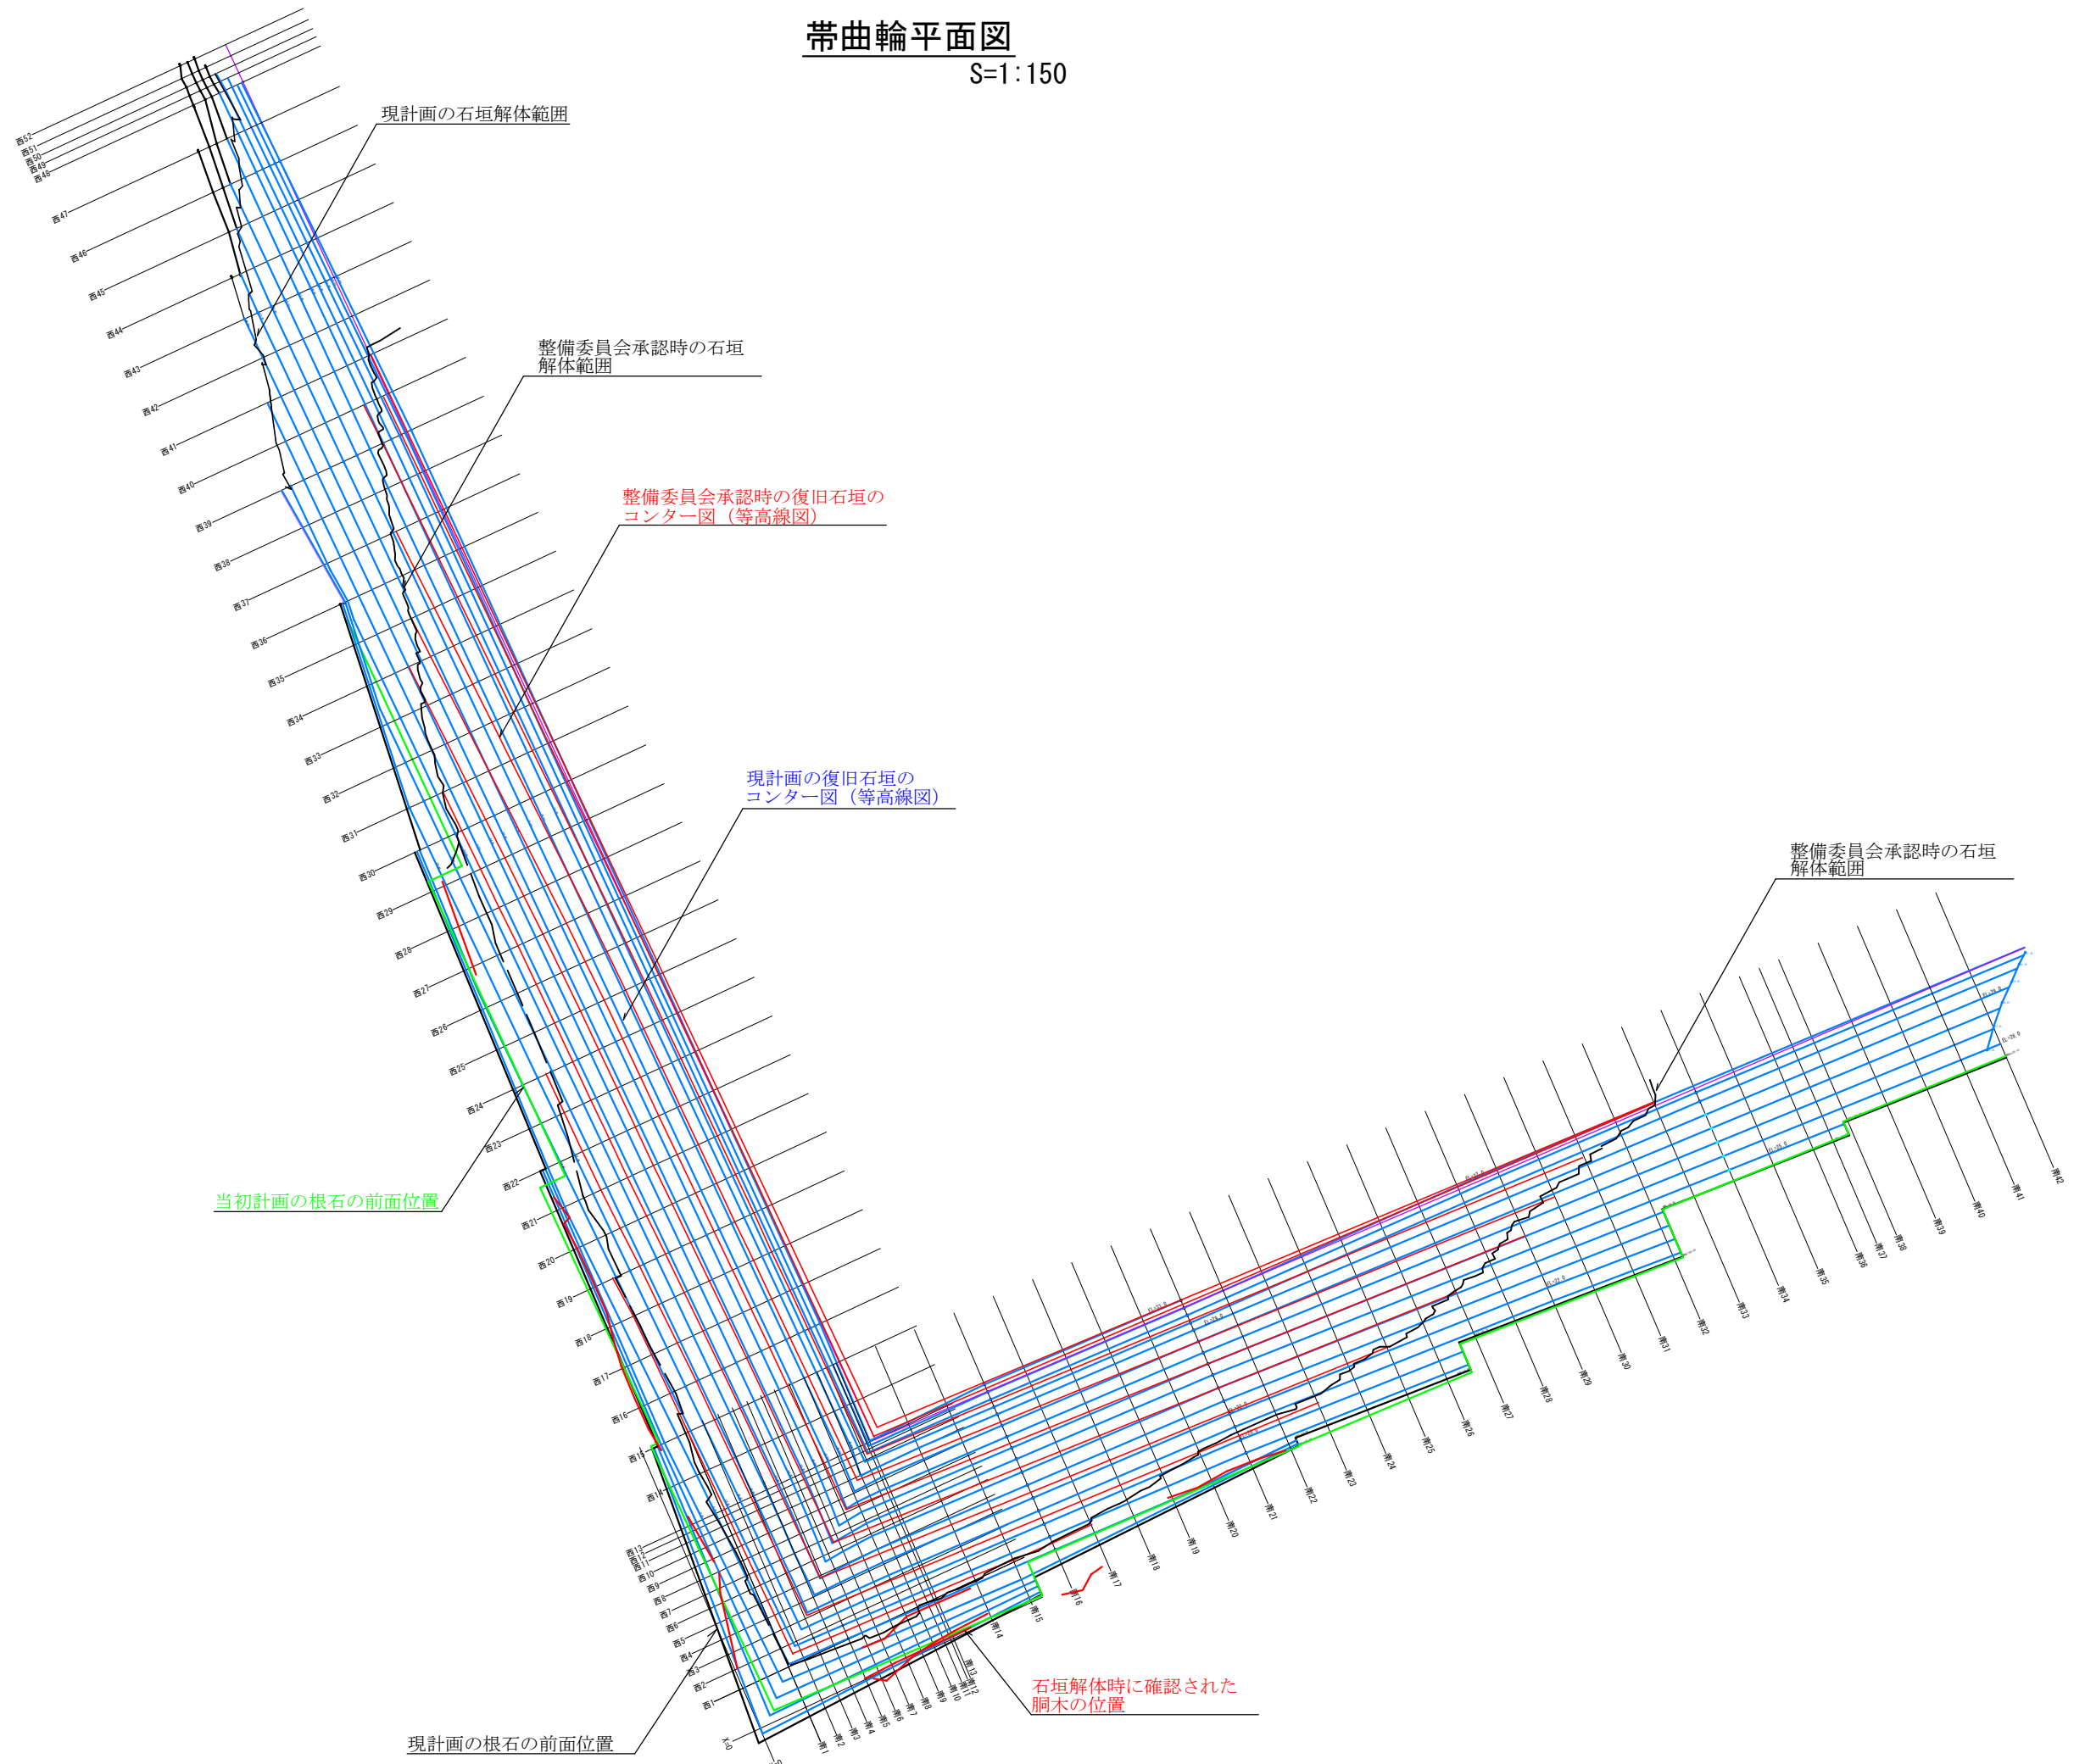
# 帯曲輪平面図

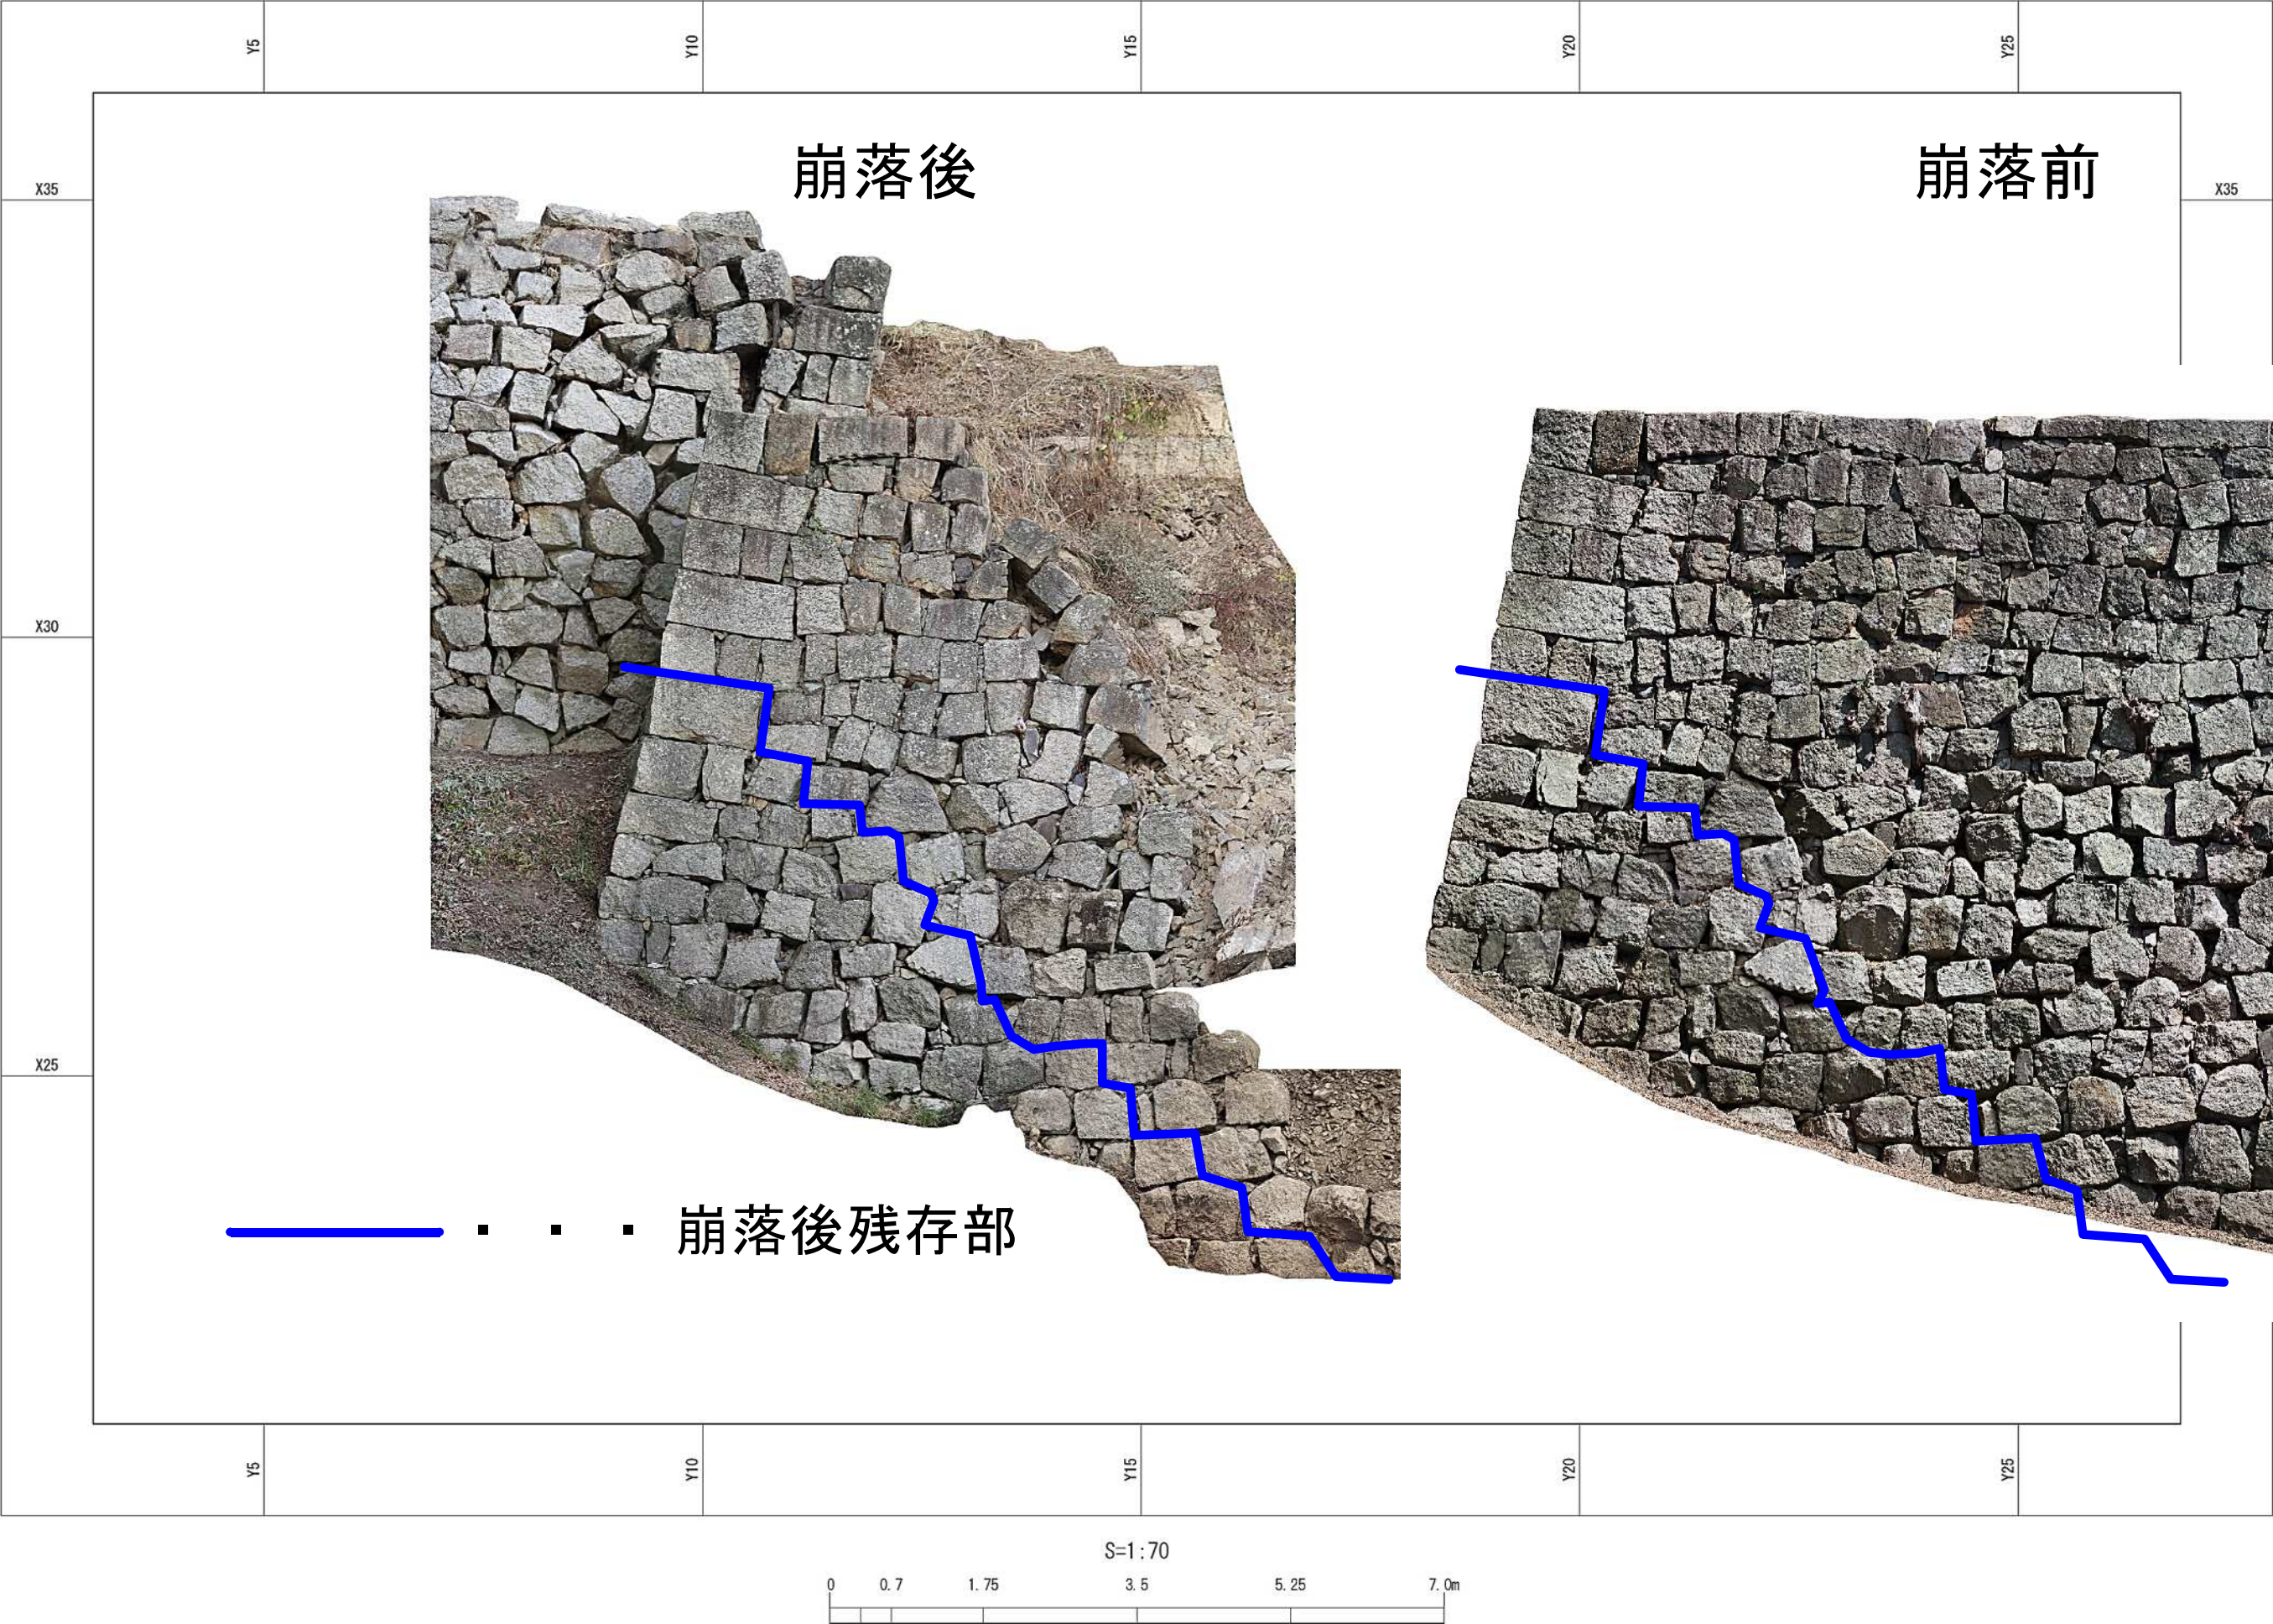
# H面崩落前後の比較

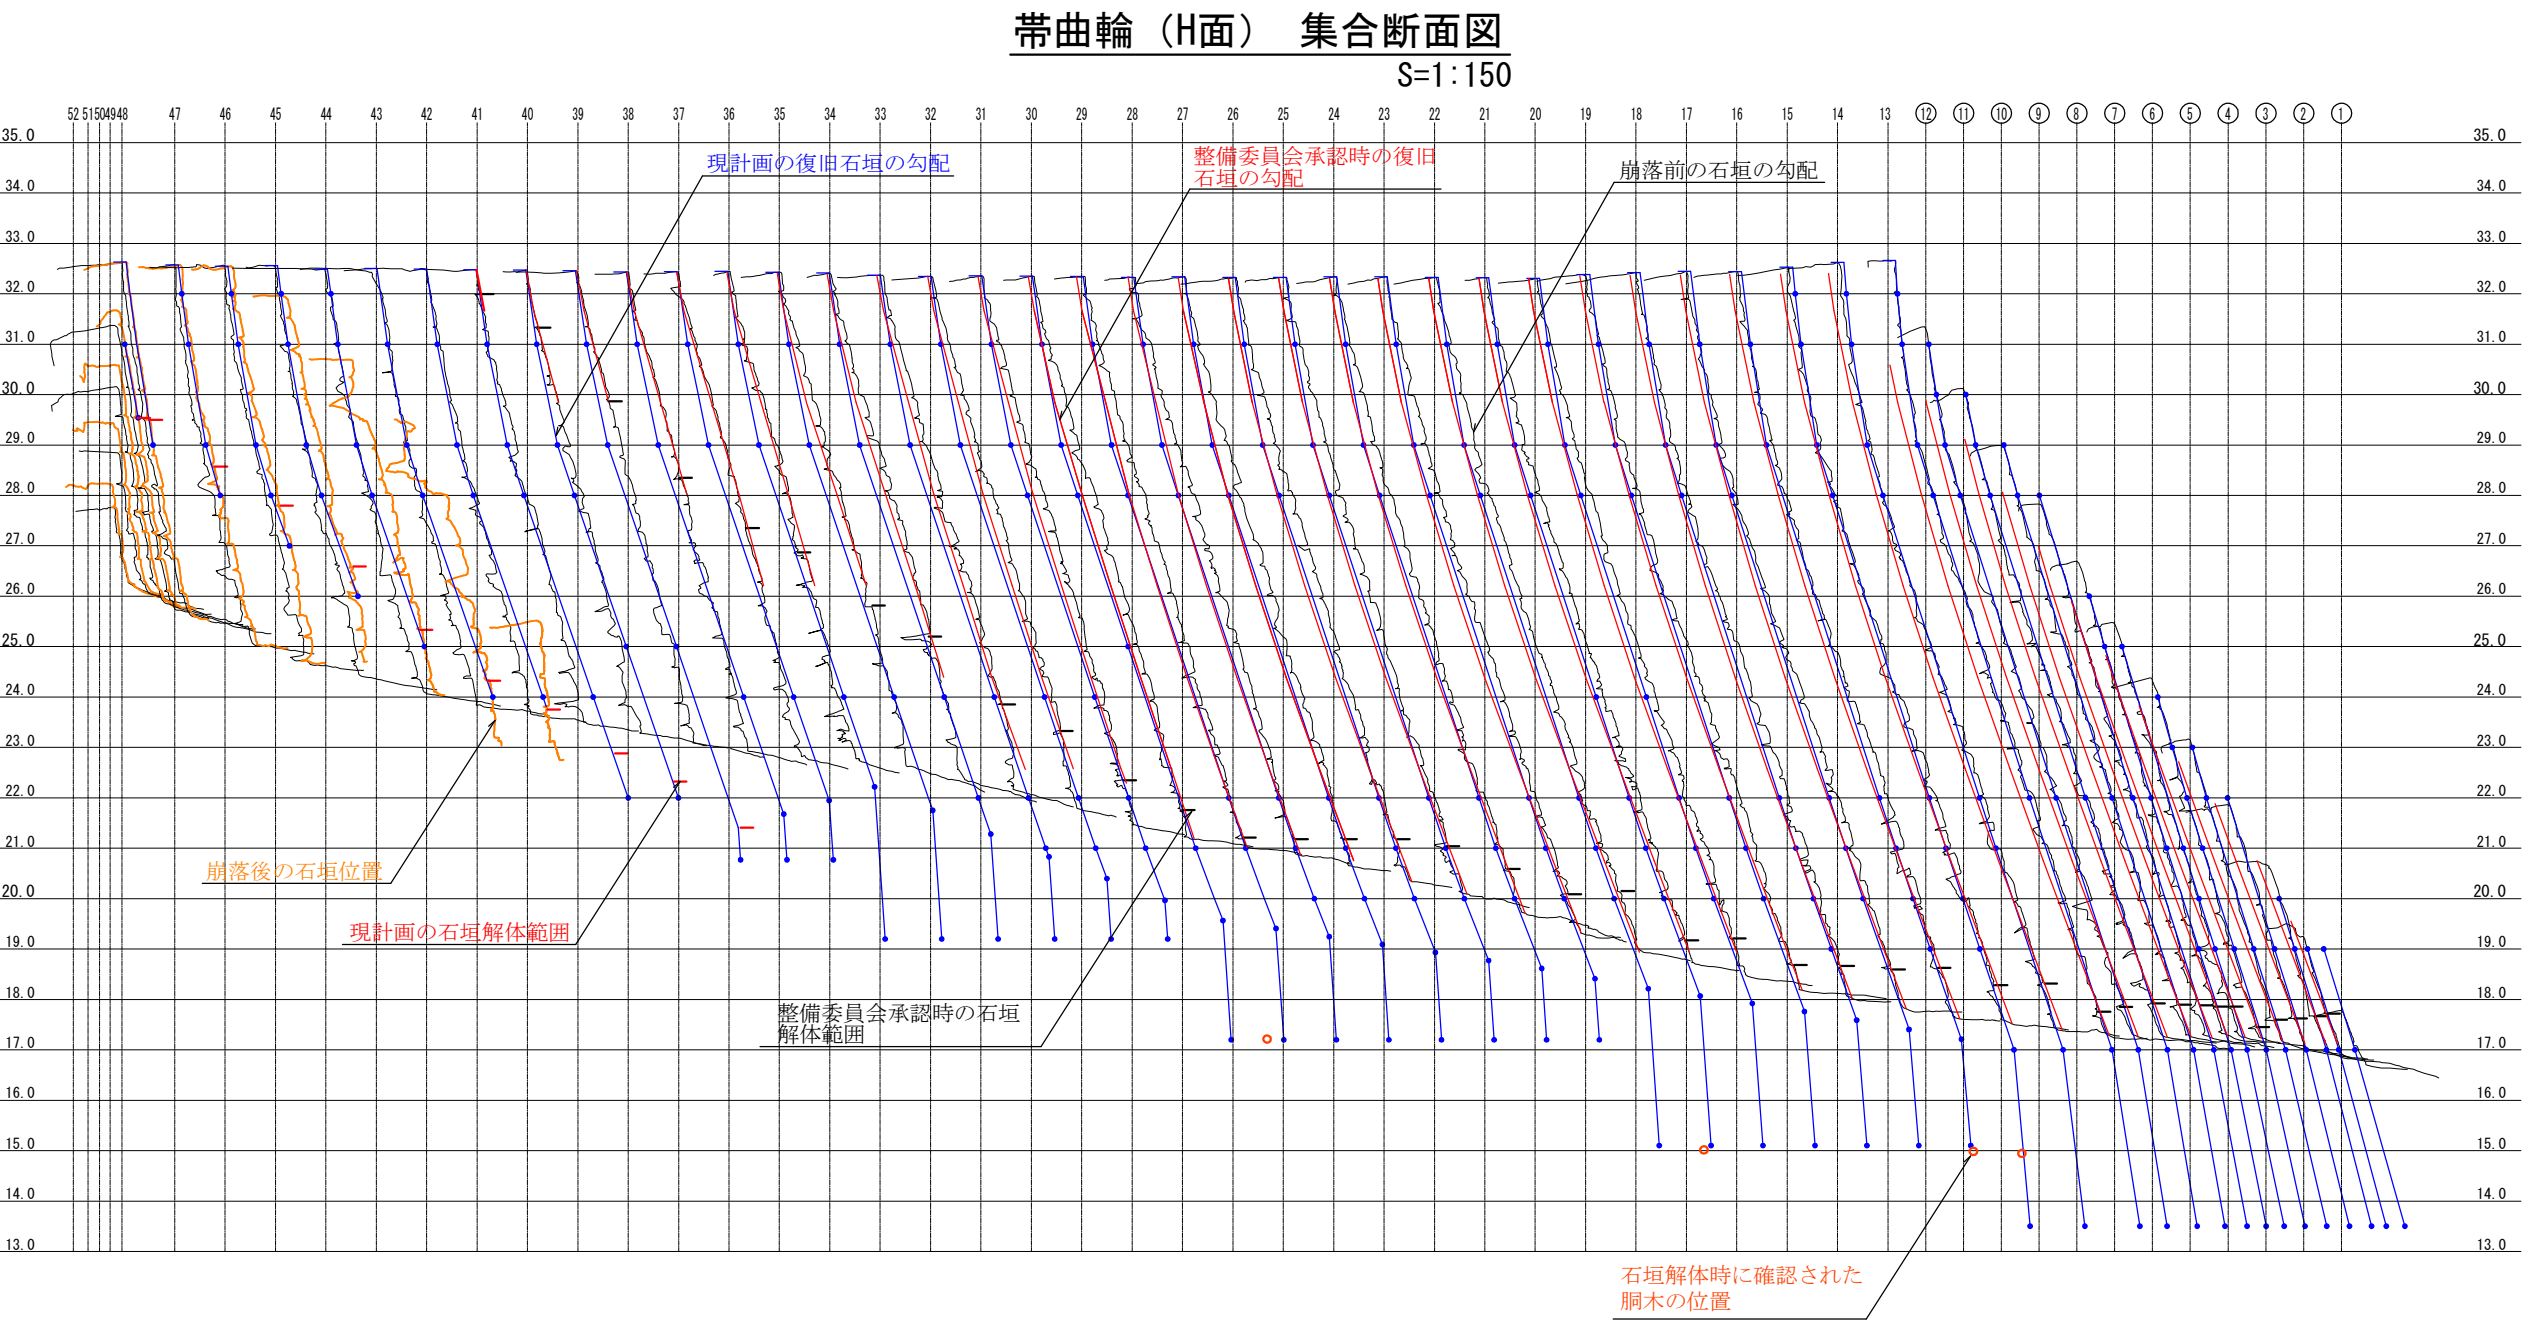
H面集合断面図
